What should we learn from the severe accidents at the Fukushima Dai-ichi Nuclear Power Plant?

Final Report

- Team H2O Project -

December, 21st, 2011

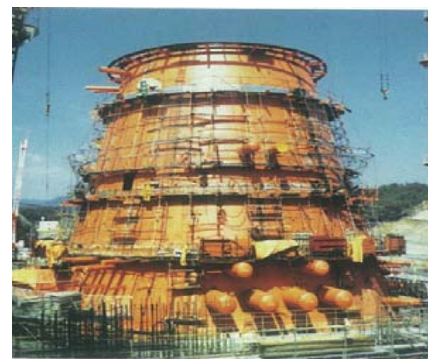
Fukushima Dai-ichi Unit 1

**BWR-5
Mark-II**
(Circular)

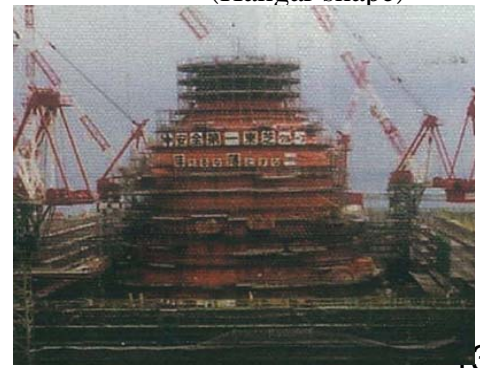
Fukushima Dai-ichi Unit 3

**BWR-5
Mark-II Improved**
(Hangar shape)

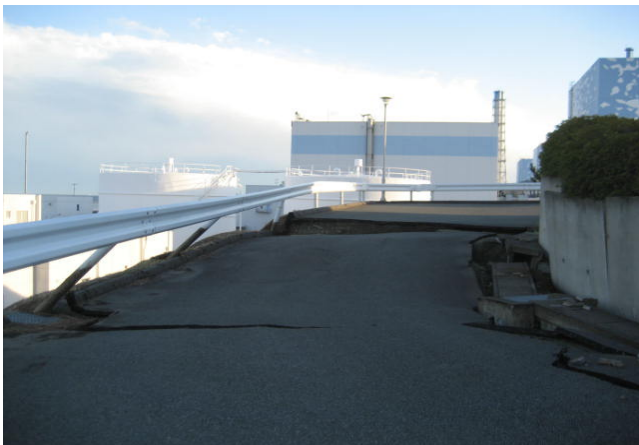
- Road is completely cracked and fissured
- Major bend in guardrail
- Many cracks along the side of the road
- People and vehicles can hardly pass

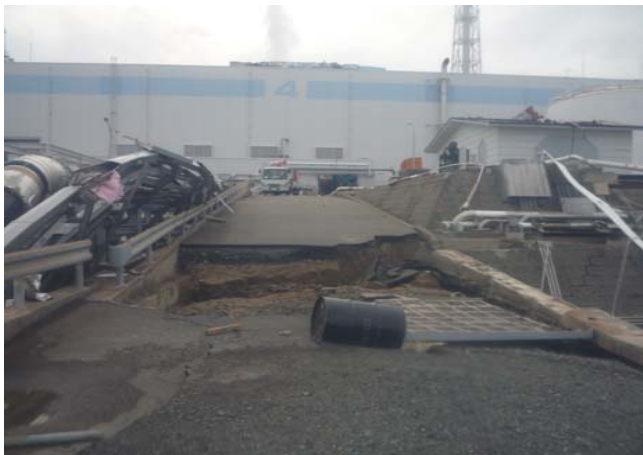
- Road has caved in for several meters
- Drum can has rolled into the middle of the street
- No cars can pass. People can hardly walk

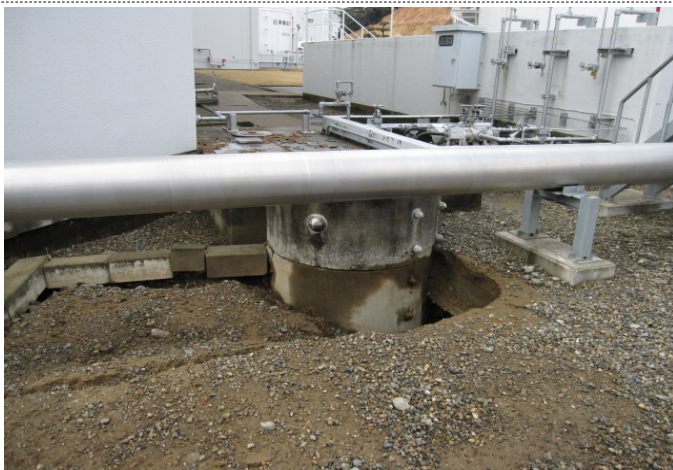
- Ground has caved in

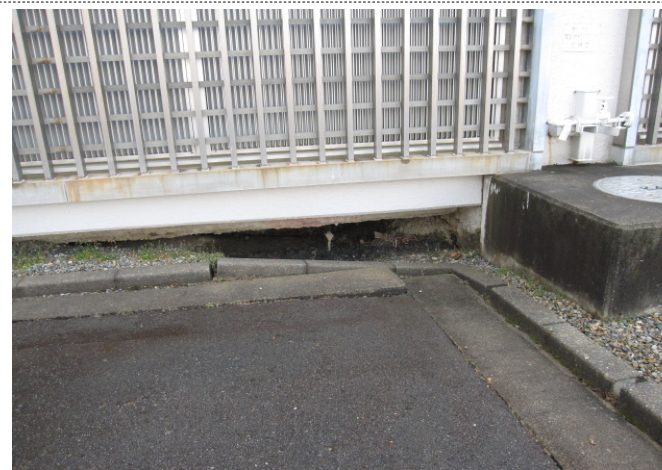
- Gap between building and ground (a depression in ground?)

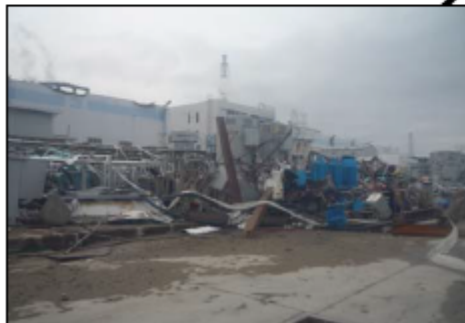
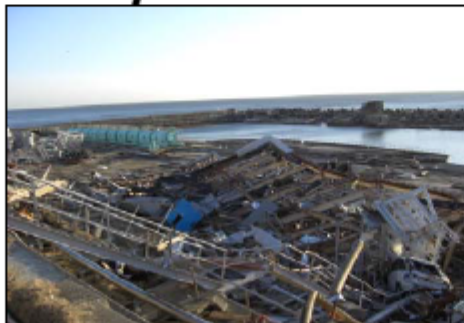
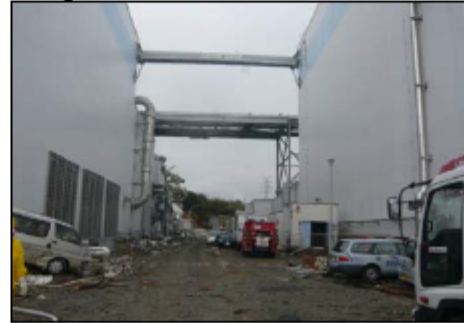
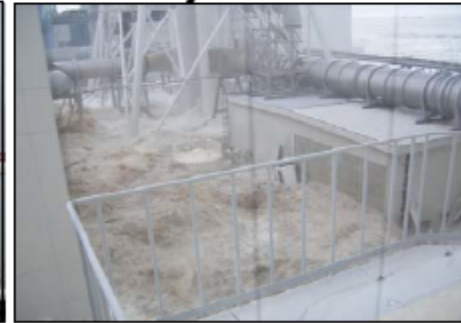
- A heap of rubble in the area of 4m altitude. Hardly transport vehicles, personnel, or supplies.

- Even at an elevation of 10m, cars had drifted. Even on the mountain side of the building, a 5.5m-height tank has been swallowed up, just like a swimming pool.

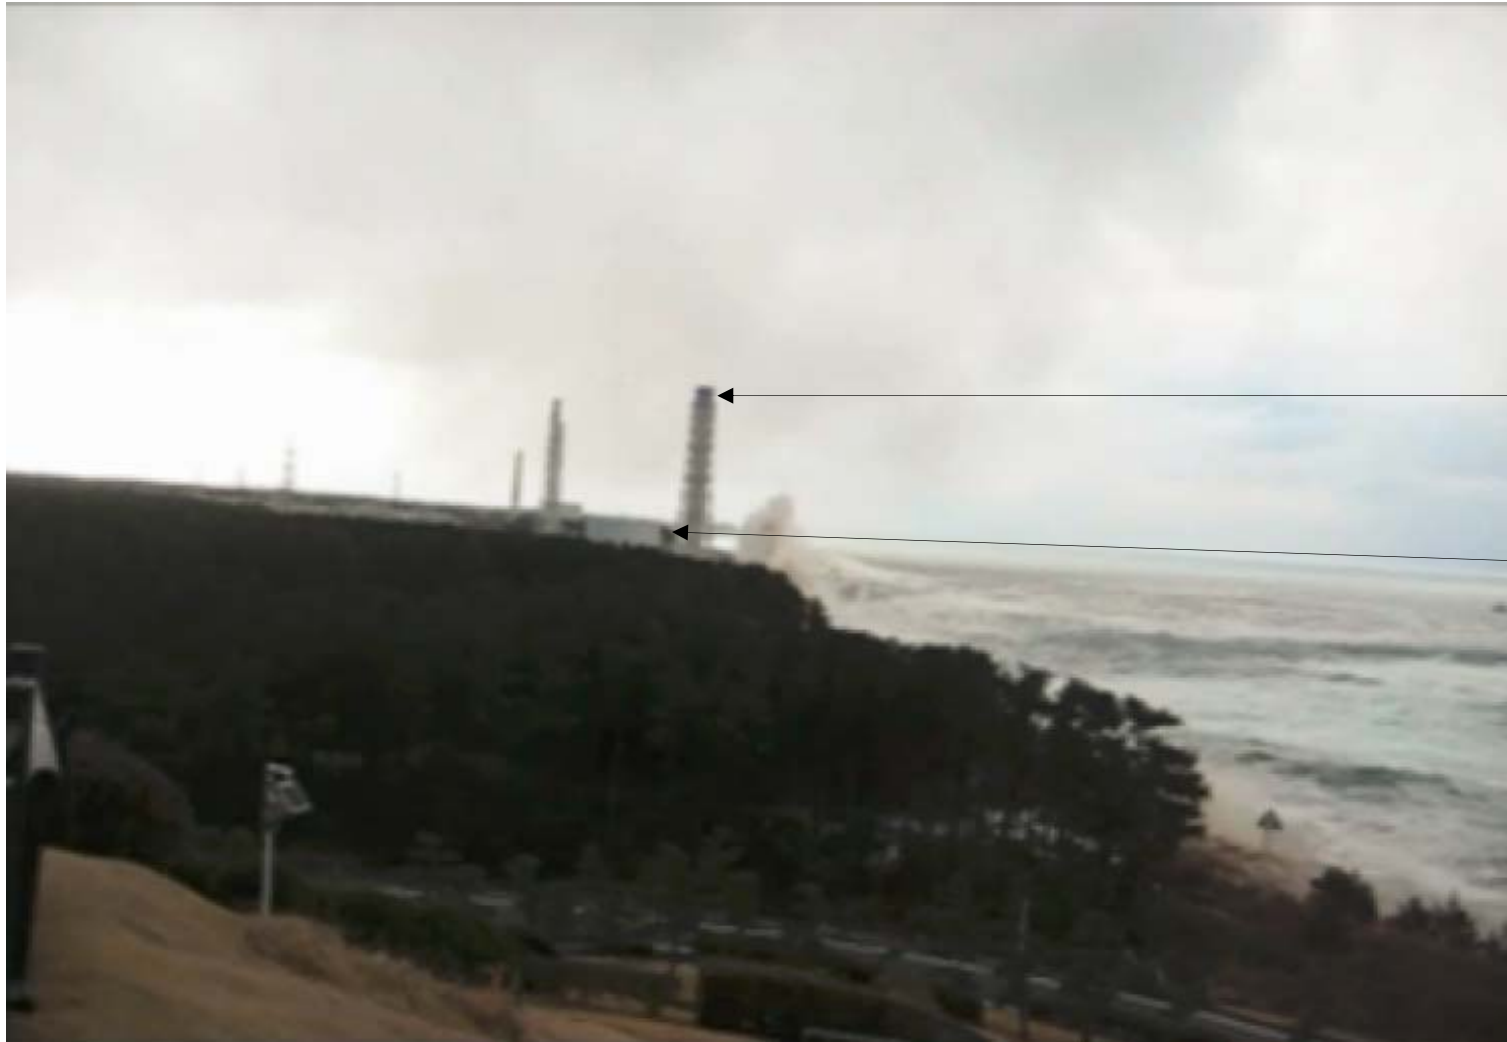
Fukushima Dai-ichi

The moment the tsunami hit: The wave, that reached at the plant, surpassed the reactor building (45 m), and came halfway up the exhaust stack (120 m).

Exhaust Stack

Nuclear Reactor Building

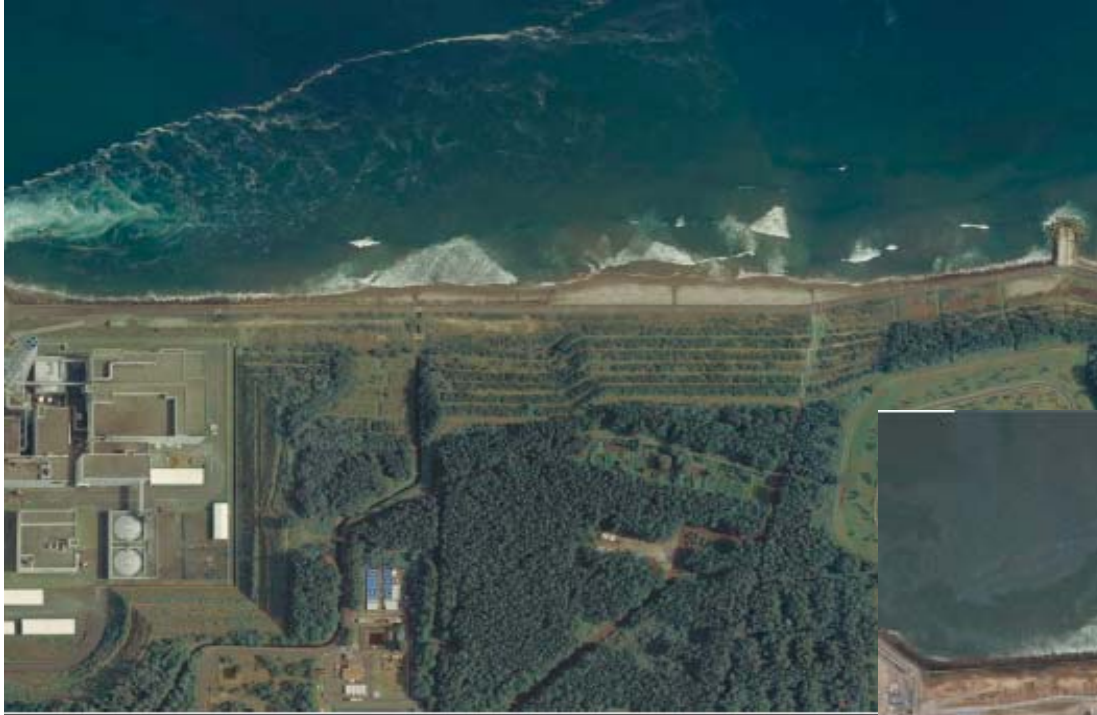
Before March 11th (Fukushima Dai-ichi Power Plant, south side of unit 4)

The Scar of Tsunami: On the south side of the plant, the forestation along the shore has been torn up from their roots.

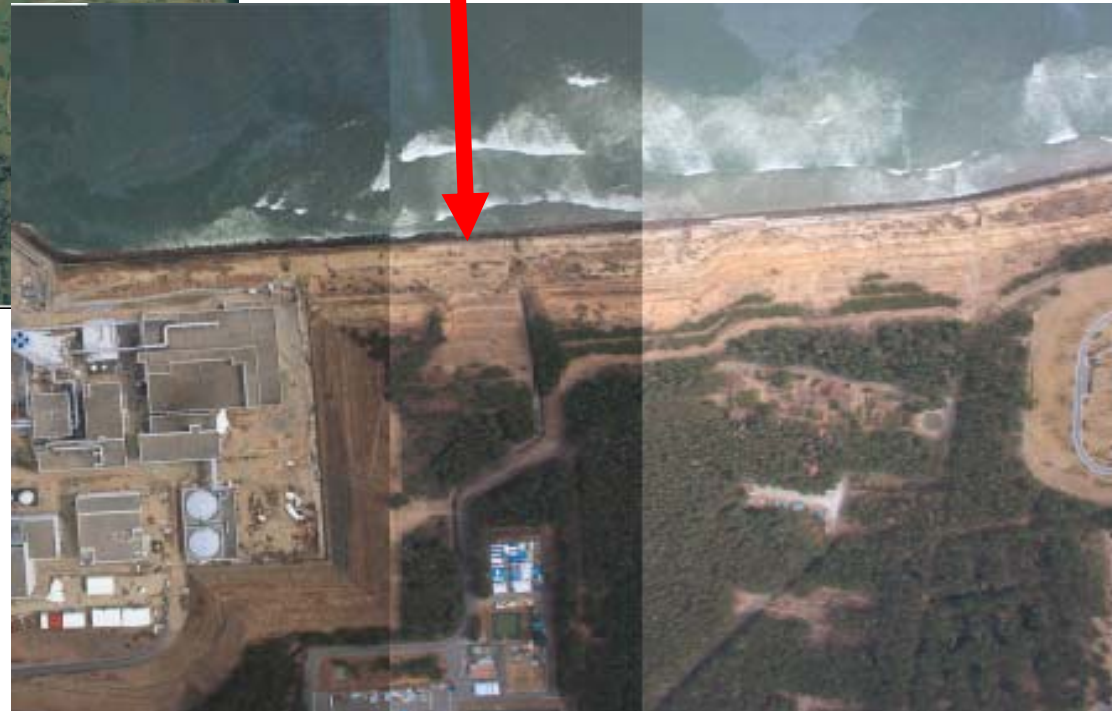
After March 11th

Forestation has been torn up from their roots

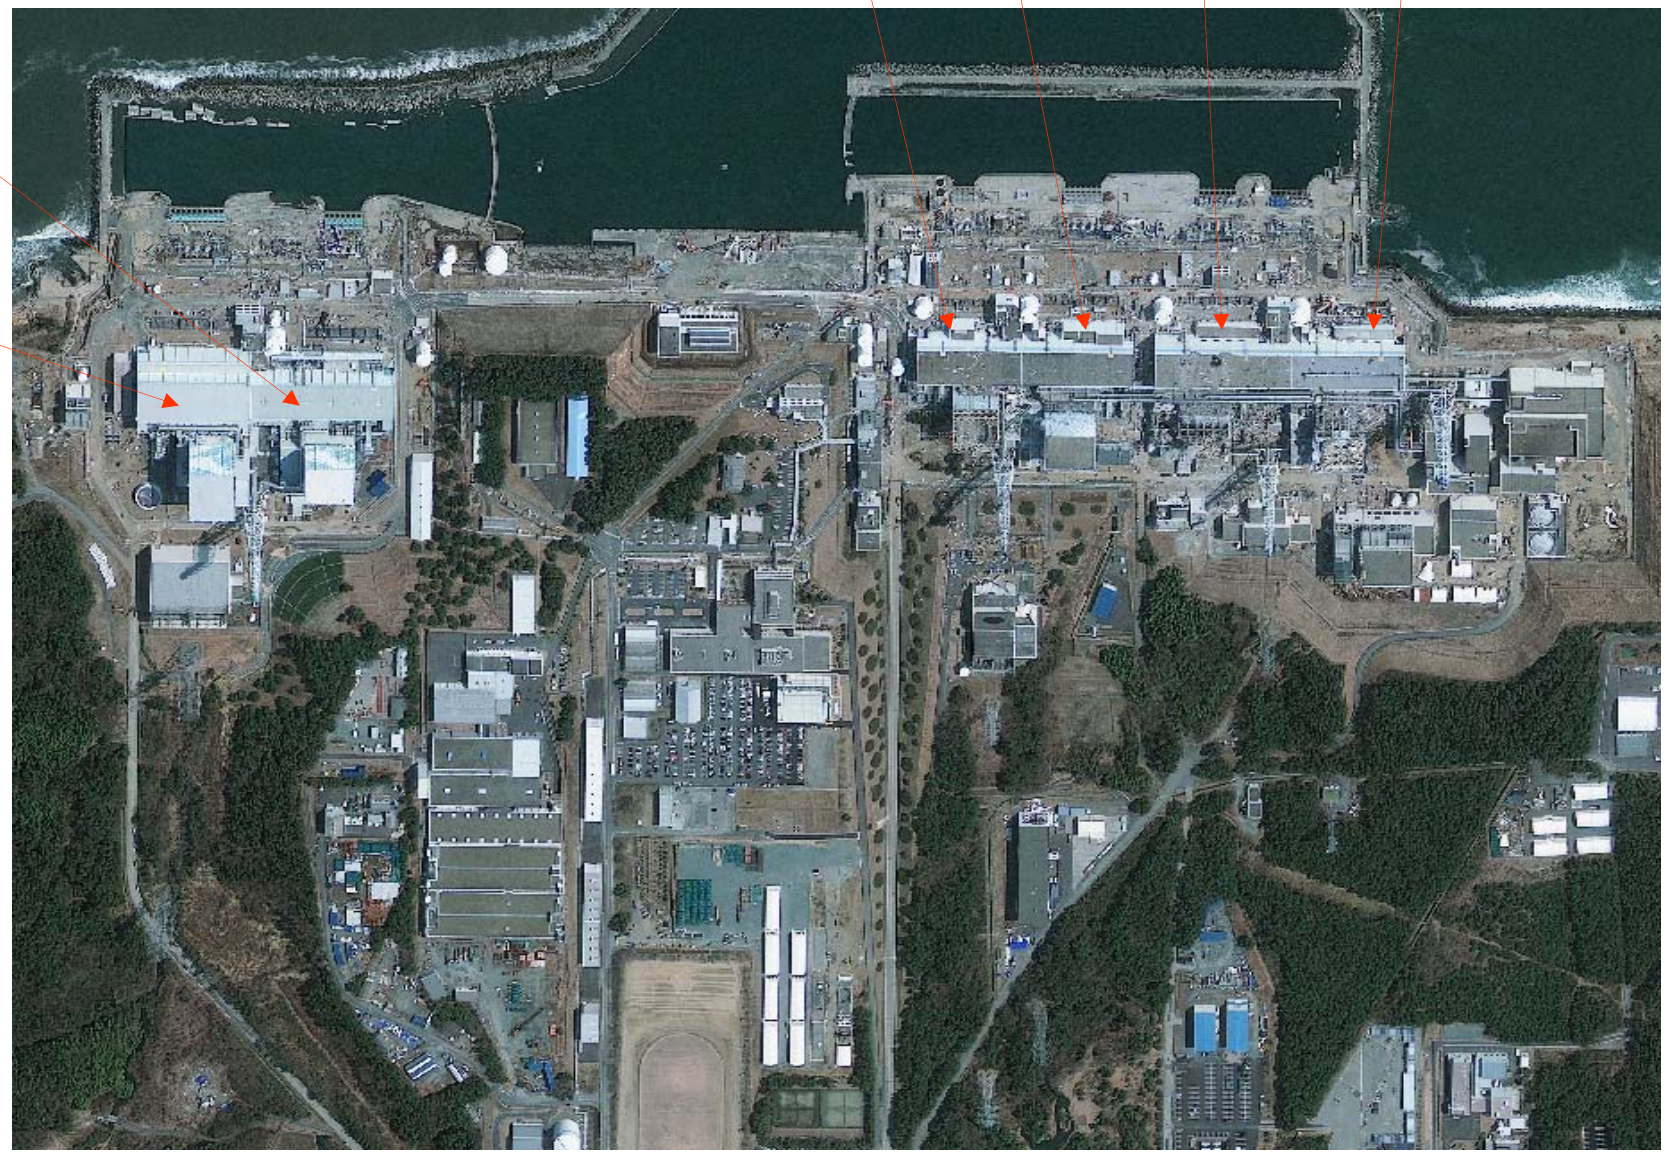
Aerial shot of Fukushima Dai-ichi: Of the 6 reactors, the units 1 - 3 were in regular operation. The units 4 - 6 halt for regular inspection.

Unit 1 (In operation) Unit 2 (In operation) Unit 3 (In operation) Unit 4 (Under regular inspection)

Unit 5 (Under regular inspection)

Unit 6 (Under regular inspection)

Ground height: Units 1, 2 and 3 (all in operation) are 10m above sea level and at a lower level than Units 5 and 6 (both at 13m).

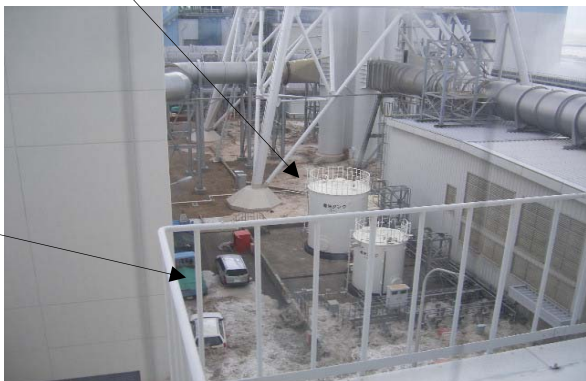
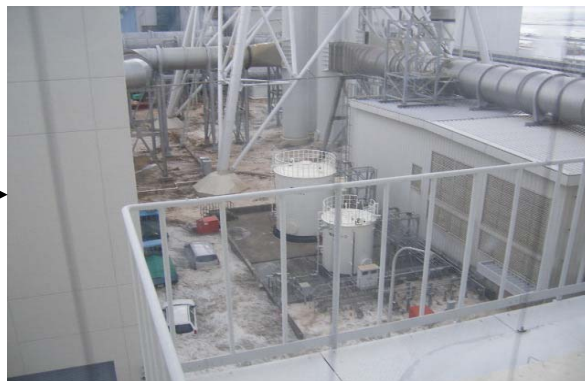
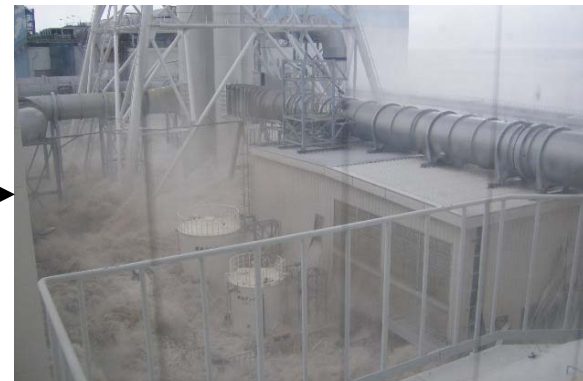
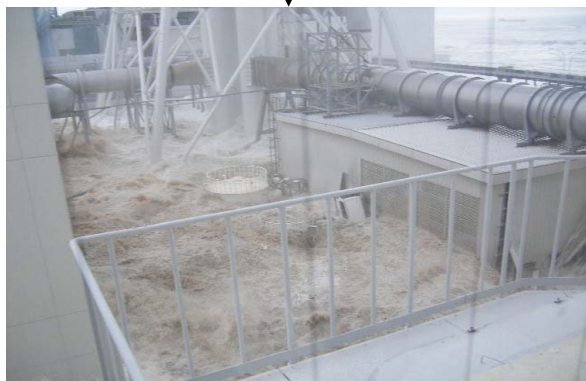
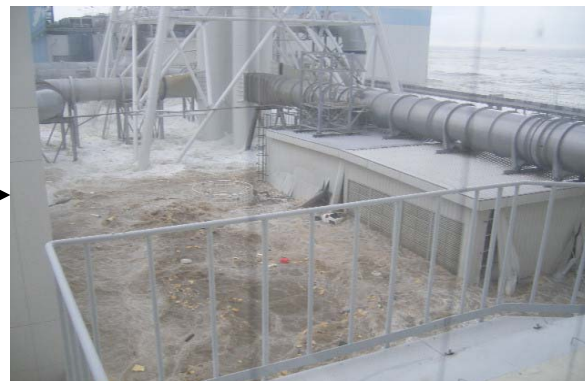
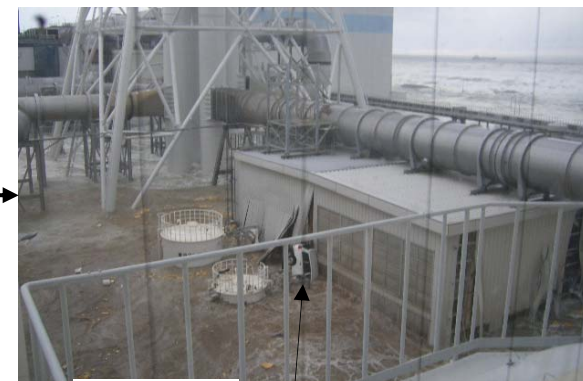
**Flooding of the yard at Dai-ichi
(near Unit 4 exhaust stack. Ground height O.P.+10m)**

Heavy fuel tank has been swallowed

The whole yard has become like a swimming pool with full of water.

The white car that was on the left side of the picture has been swept aside and is now stuck in the outer wall of the building

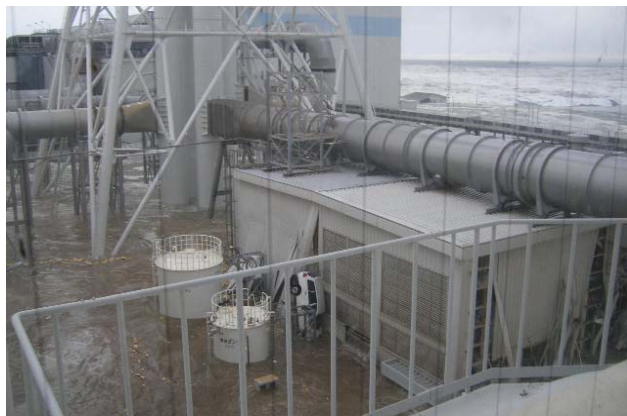
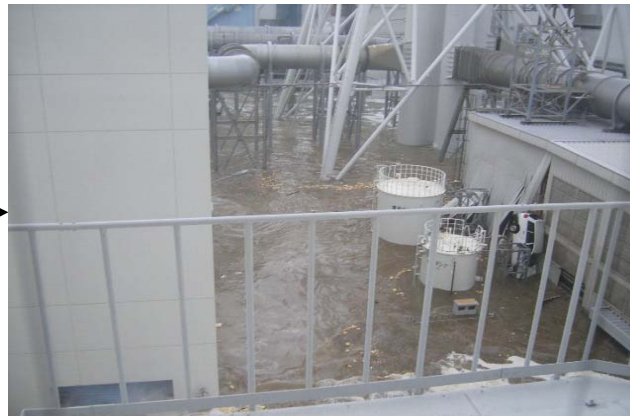
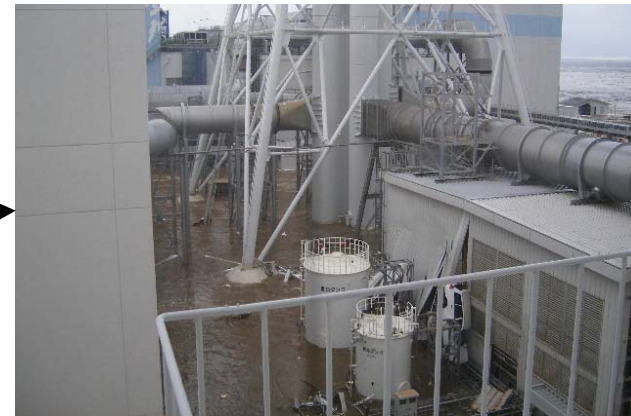
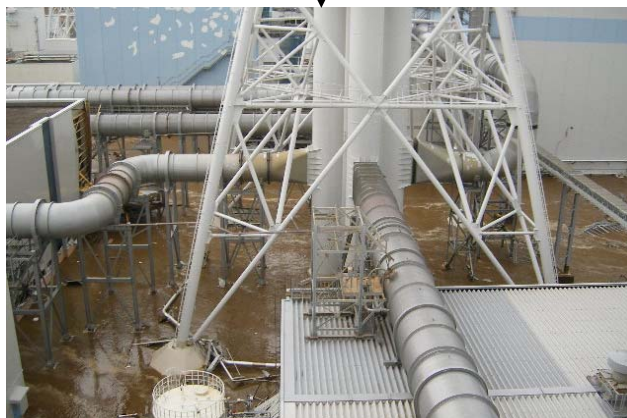
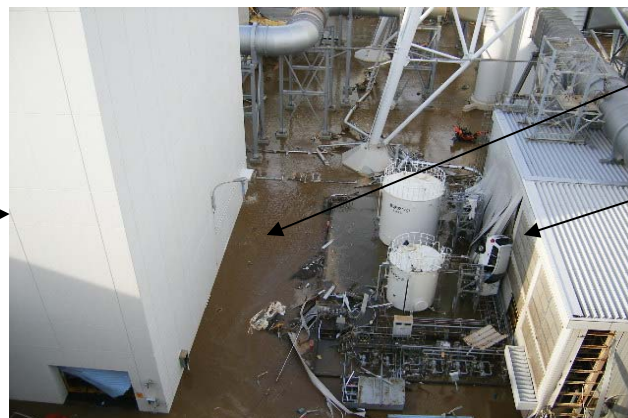
Flooding of the yard at Dai-ichi (near Unit 4 exhaust stack. Ground height O.P.+10m)

Flooding (continued): The 3 vehicles were completely drifted by the tsunami.

Several cars in the first photo have been completely drifted.

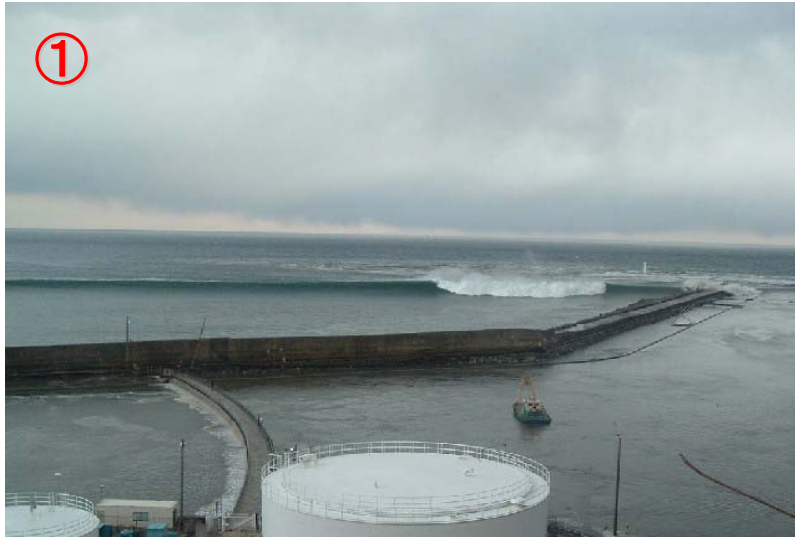
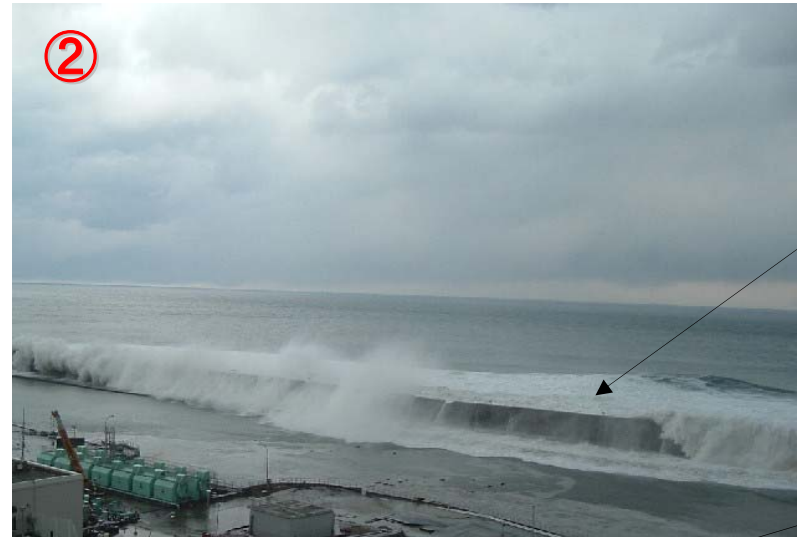
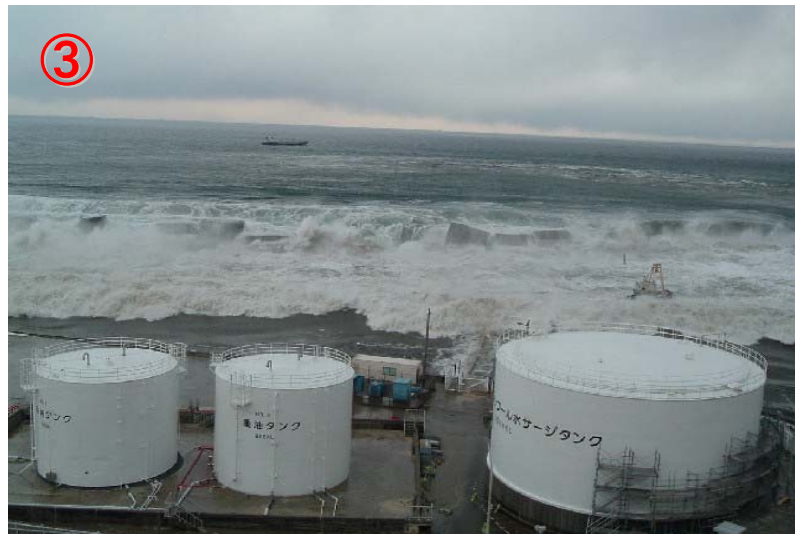
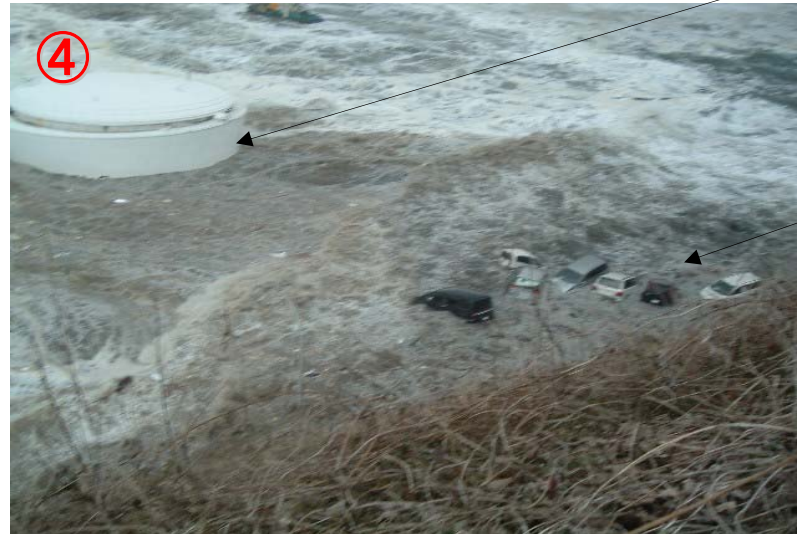
East side of solid waste storage (southeast seaside of unit 5)

Seaside at the moment the tsunami hit: Tsunami easily overcame the 10m levee, drifted a number of cars, and almost completely swallowed the giant tank.

Tsunami easily flooding over the 10m levee.

Giant surge tank of photo 3 is submerged up to here.

Cars are drifted from elsewhere

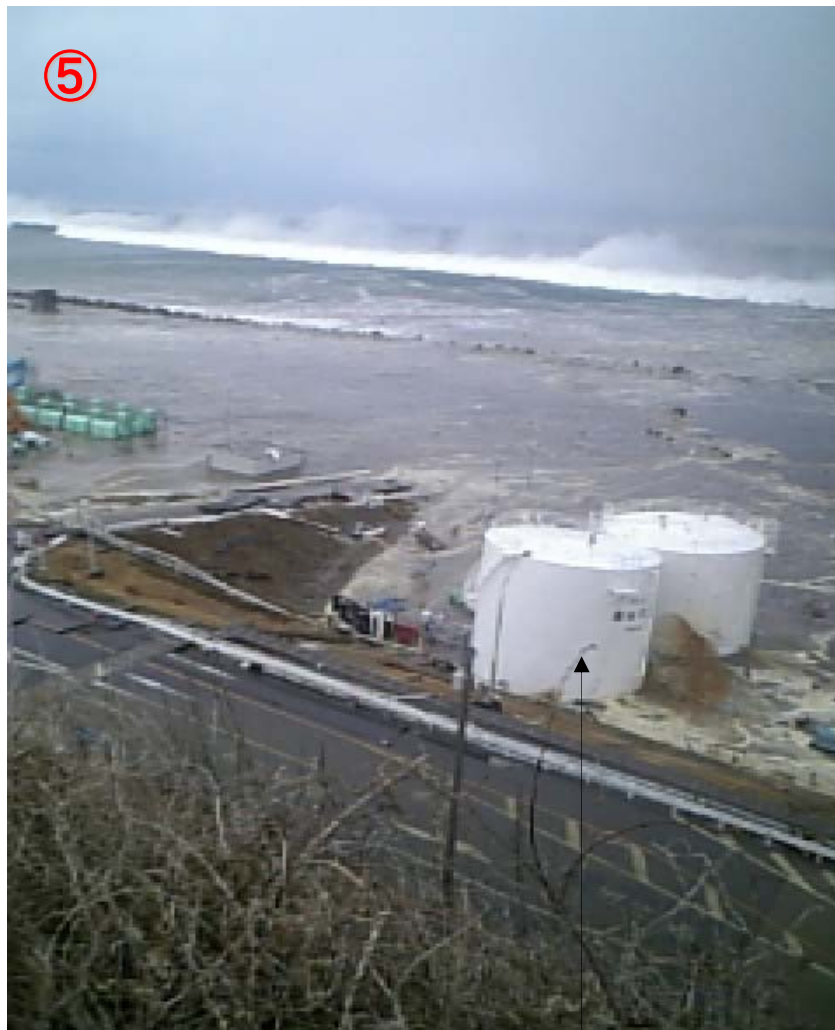
(Continued) The 2 heavy fuel tanks have been drifted onto the road. The side of the surge tank has been bent like a twisted PET bottle.

2 heavy fuel tanks have been drifted, and pushed up towards the roadside.

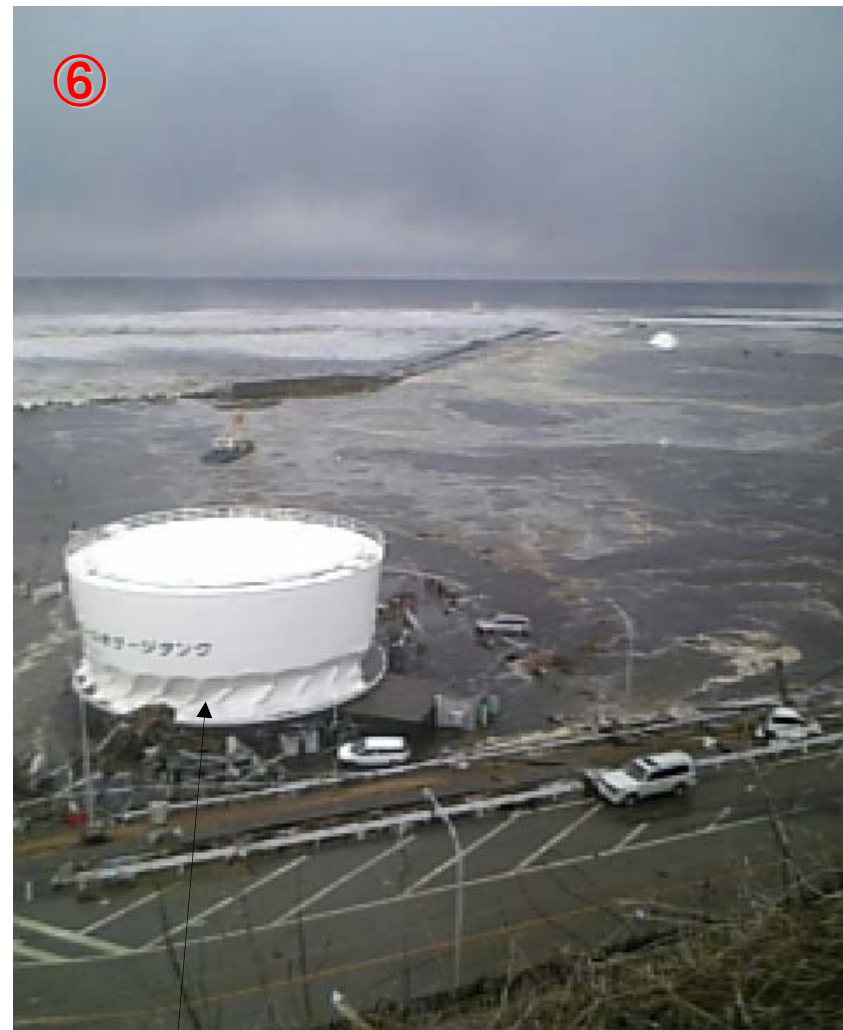
The entire body of the giant surge tank has been contorted as if a PET bottle is wrenched

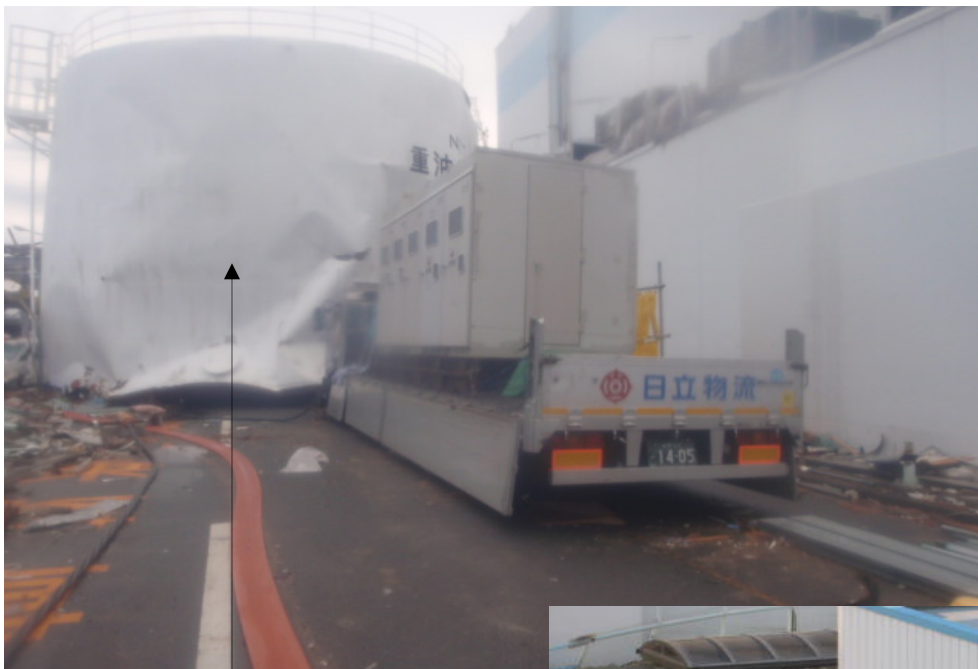
(Continued) Myriads of rubbles, drifts, and damage made it extremely difficult to transport people and supplies after the tsunami.

A heavy fuel tank has been drifted, and has completely blocked the road.

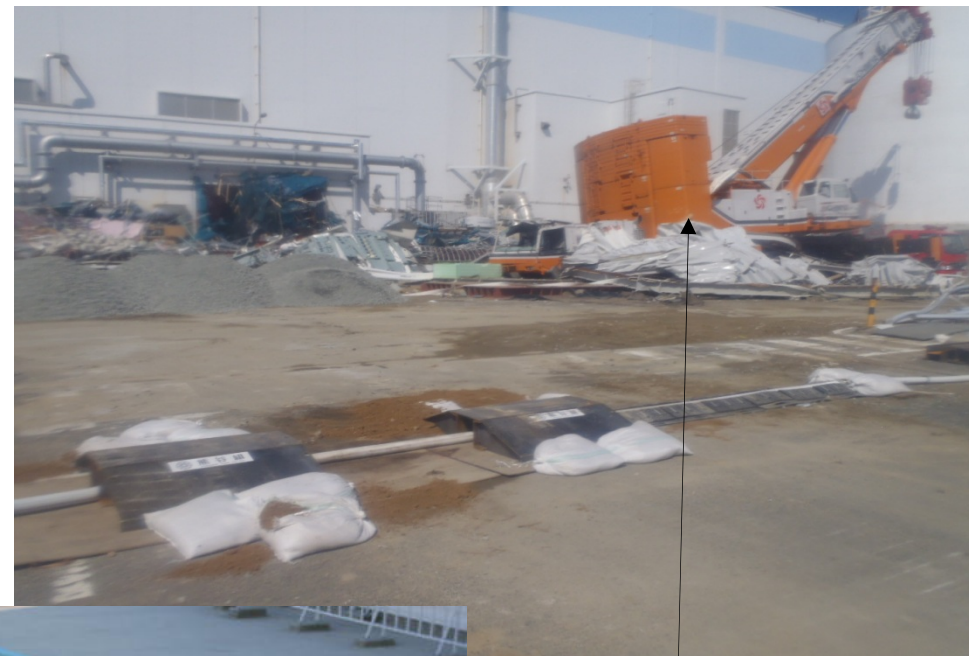
Crane vehicle (45t) and debris have been drifted, and obstructed the access to the building

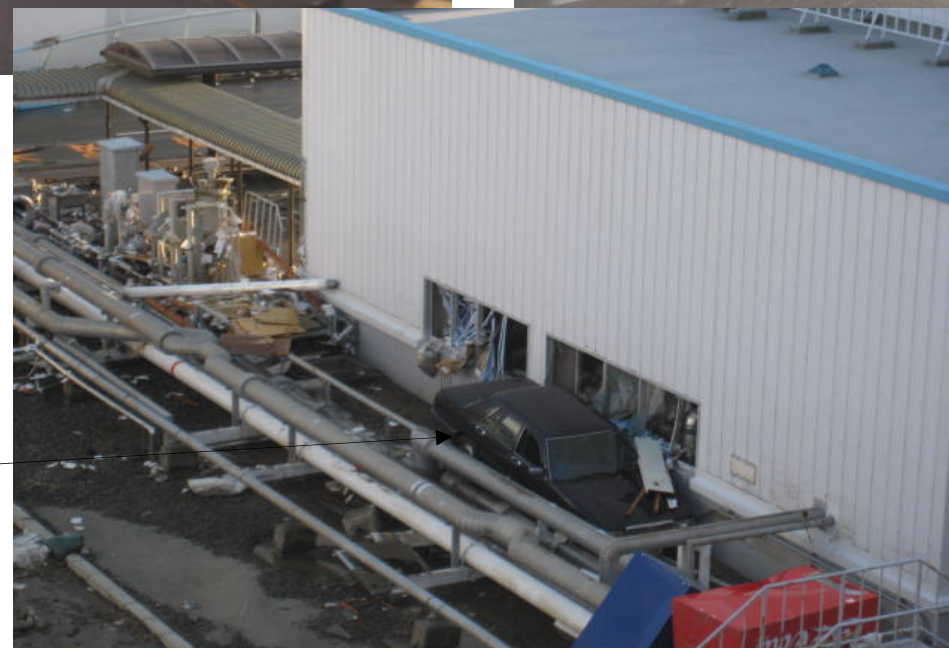
A drifted car is stuck between the pipes and building.

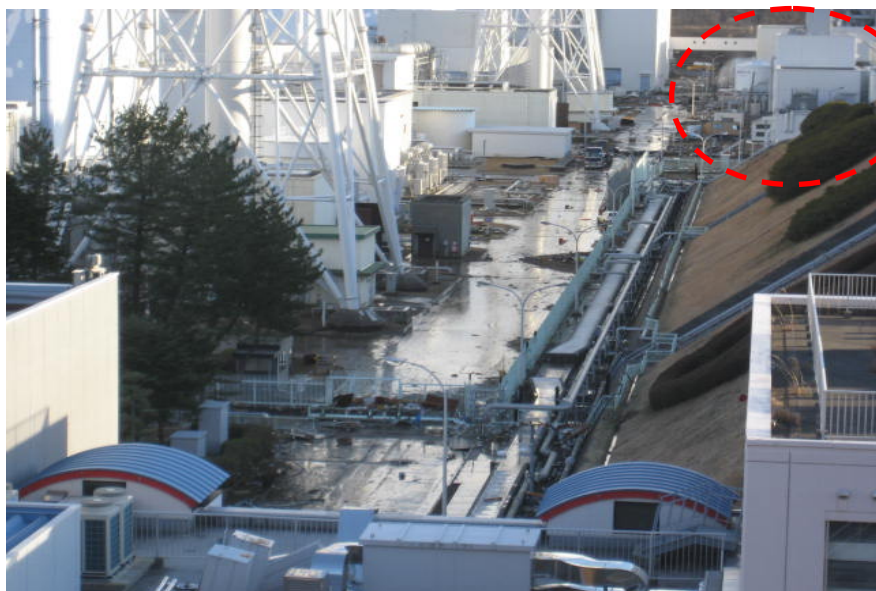
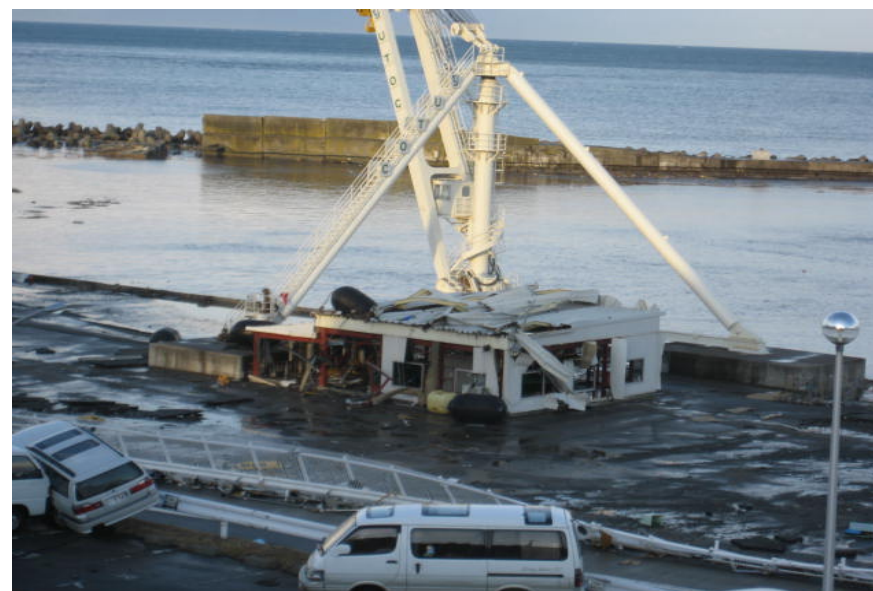
② **Landslides and rubble by the tsunami made the transportation of people and supplies extremely difficult.**

Damage of Tsunami: An oil fence is stuck into the building. The road is severely liquefied. Along with scattered debris, it is far from passable during the day, and impossible to walk during the night without light.

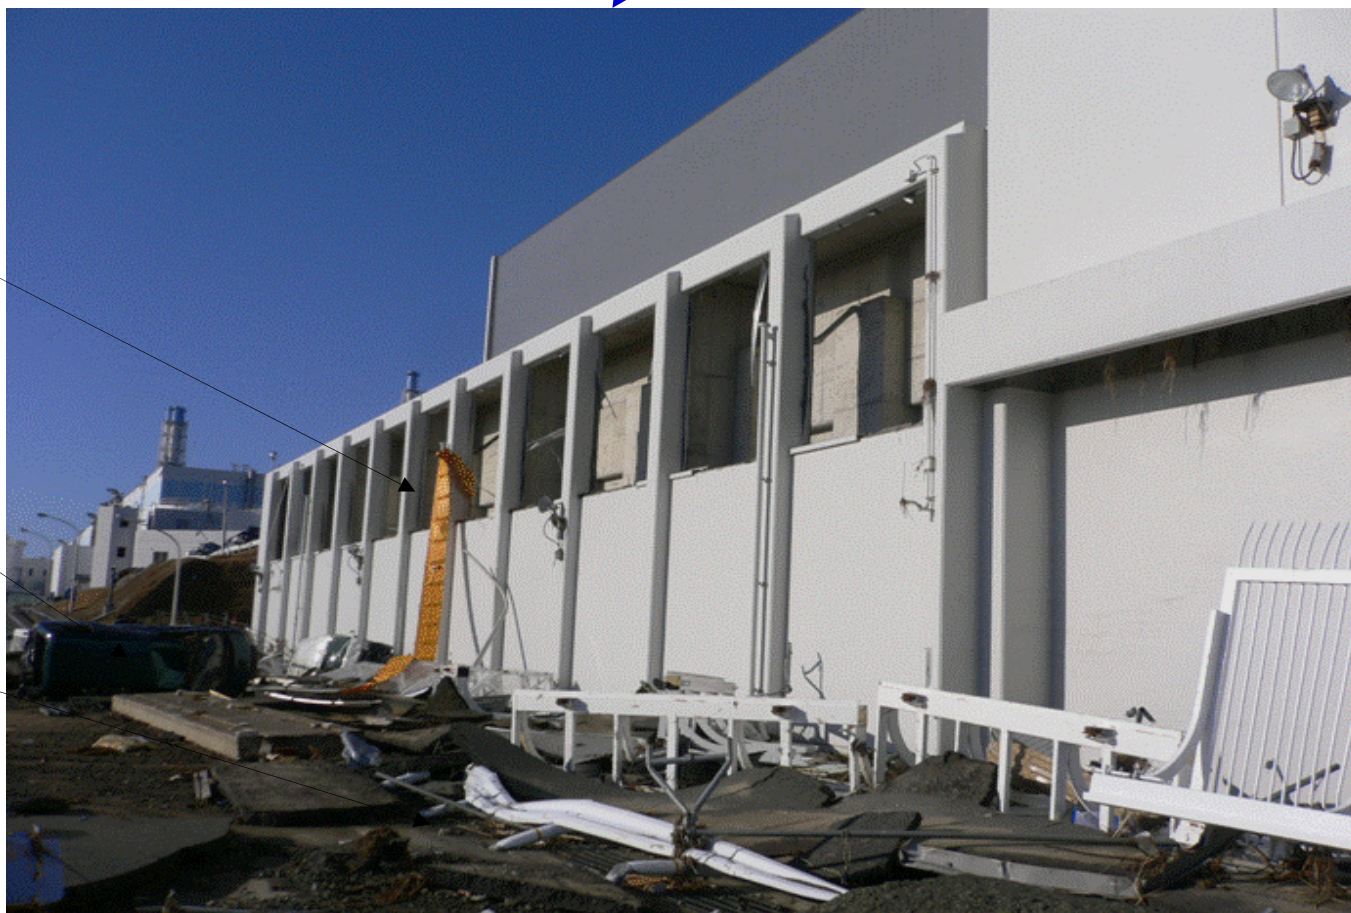
Surroundings of storage/cask buildings

Several-meter large pieces of asphalt or concrete debris are drifted, fractured, and scattered around.

Road is severely liquefied

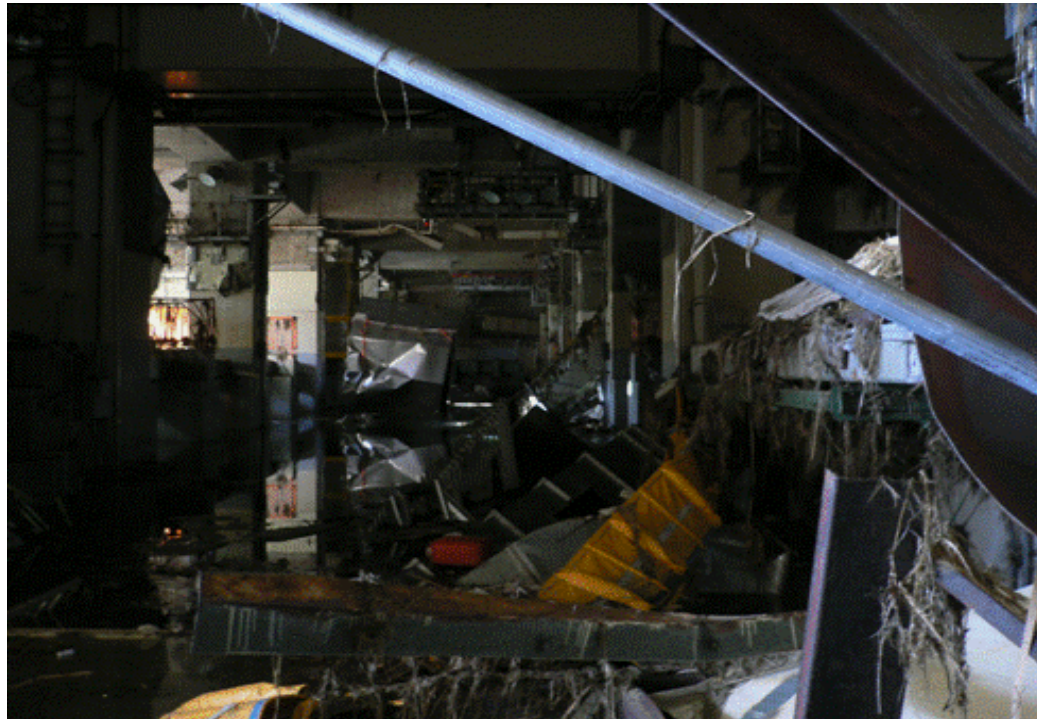
Inside of storage/cask buildings

Damage of Tsunami: In the storage and cask buildings, a car was swept in and stuck vertically. Heavy debris is strewn over. There is no walking space.

Debris and furniture are completely strewn over the floor. No place for foothold.

A car was swept in and stuck vertically in the ground

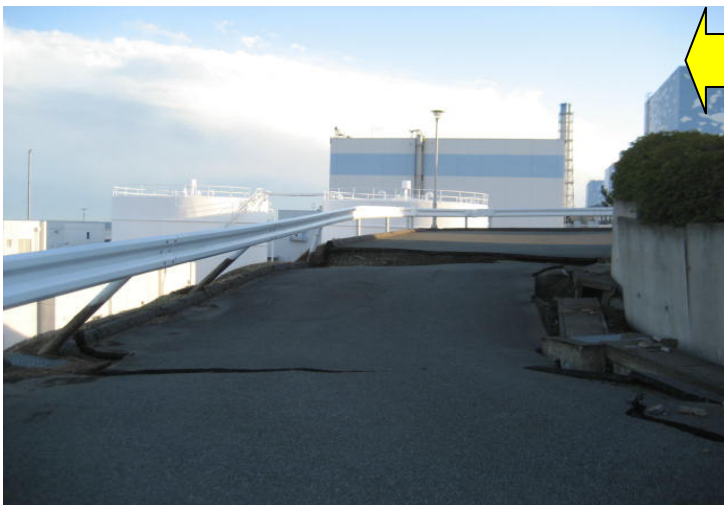
Cave-ins of roads

Liquefaction, numerous debris, and fractures of roads have made transport of people and supplies extremely difficult. Furthermore, the complete darkness at night has made the work environment extremely hard.

- **Extremely bad access by frequent aftershocks, opened manhole, chasms, cave-ins, and liquefaction of the ground**
- **Complete darkness at night**
- **Access routes were extraordinarily obstructed.**

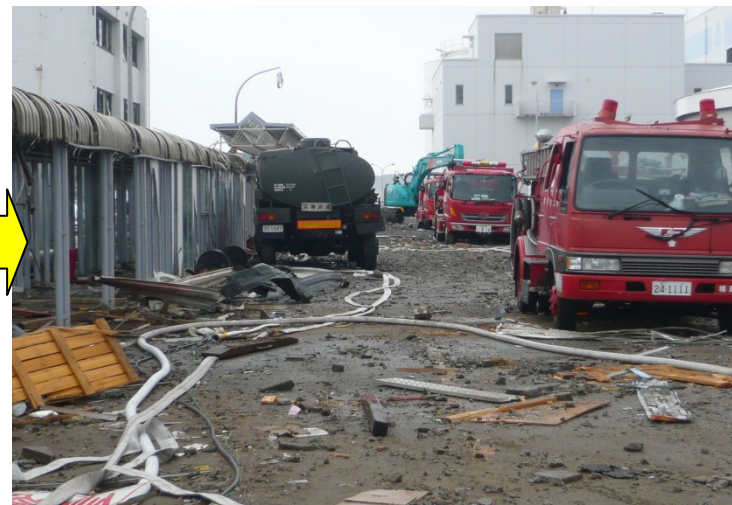
Access is circumvented by strewn fire hoses. After the explosion, further obstruction by debris, and damaged fire trucks are added.

Wood from shutter destruction

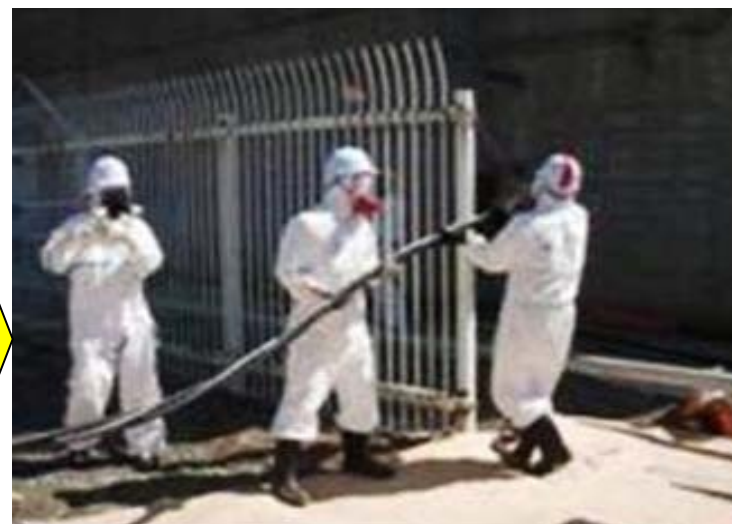
Setting up makeshift power supply cables

Cables are moved by the staff of not only power company but also other firms.

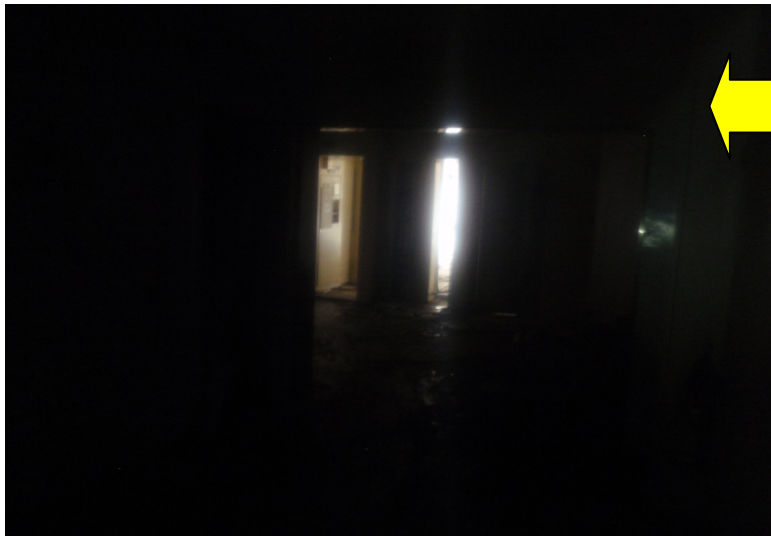
Operations in the darkness

- Due to power loss, they had to operate under complete darkness in the building.
- Due to power loss, they installed makeshift batteries to monitoring instruments.

Photo of the service building entrance from inside. Debris strewn on the floor.

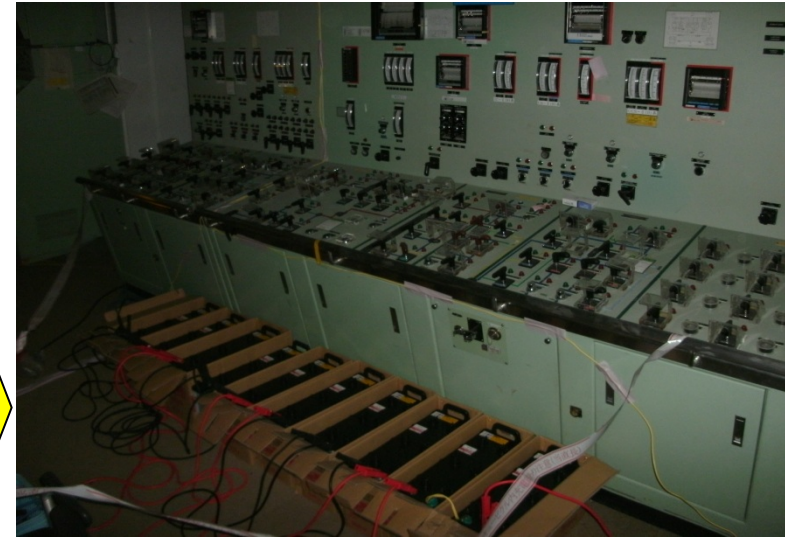
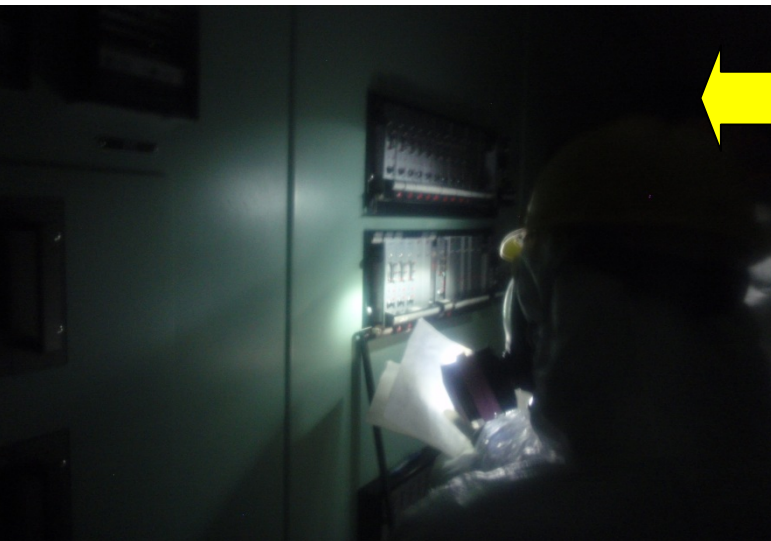
Makeshift batteries for instruments

Connected makeshift batteries for monitoring instruments.

Monitoring of parameters and data

Monitoring parameters in the dark with hand lights.

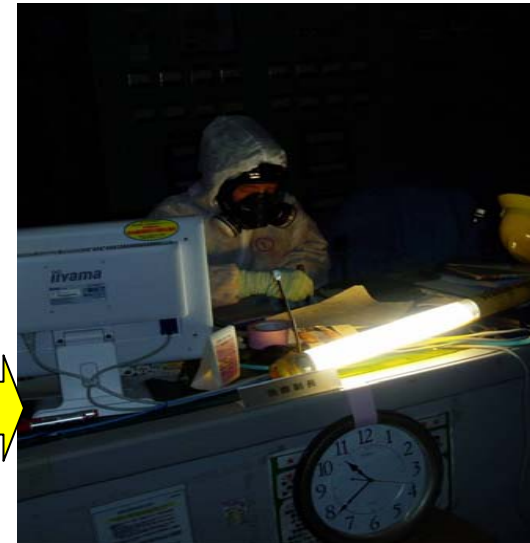
Direction by Duty Chief

Duty chief at desk in the darkness with full mask.

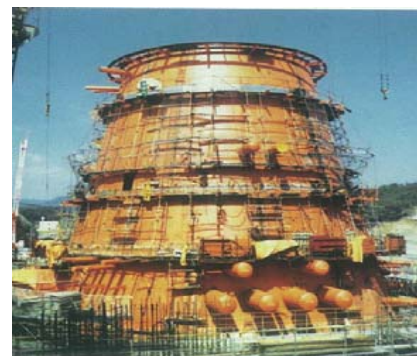
Fukushima Dai-ri Unit 1

**BWR-5
Mark-II
(Circular)**

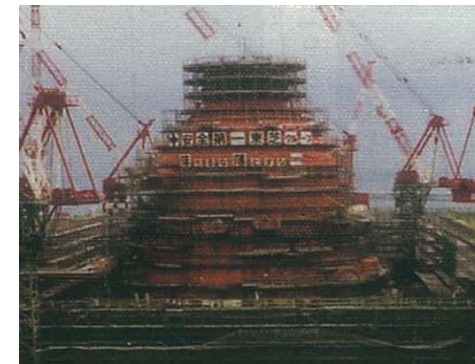
Fukushima Dai-ri Unit 3

**BWR-5
Mark-II Improved
(Hangar shape)**
