What should we learn from the severe accidents at the Fukushima Dai-ichi Nuclear Power Plant?

Final Report

- Team H2O Project -

December, 21st, 2011

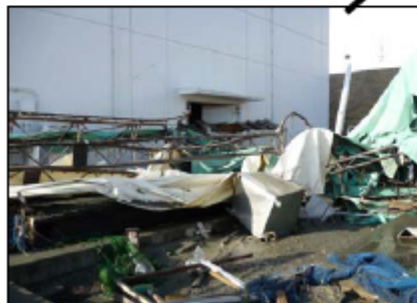
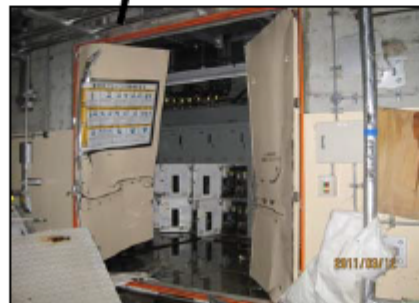
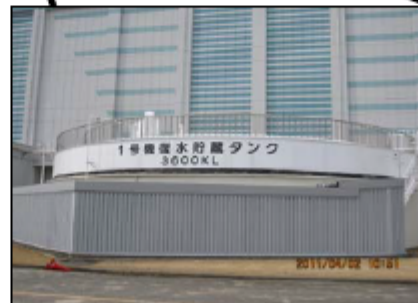
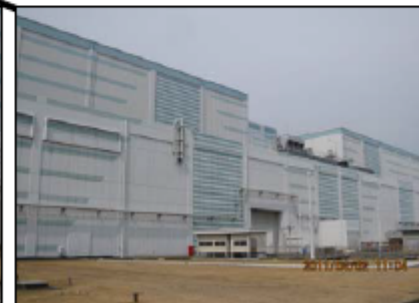
< Ground height and tsunami image at Fukushima Dai-ni Units 1-4 >

**Actual inundation height
= + 7m**
(14m only at south side of unit 1)

- On the sea side, 4m above sea level, debris is scattered as in Dai-ichi, and it is extremely difficult to transport vehicles, personnel, or supplies.

- At 12m above sea level, breakage of buildings, facilities, or scattering of debris can barely be seen.

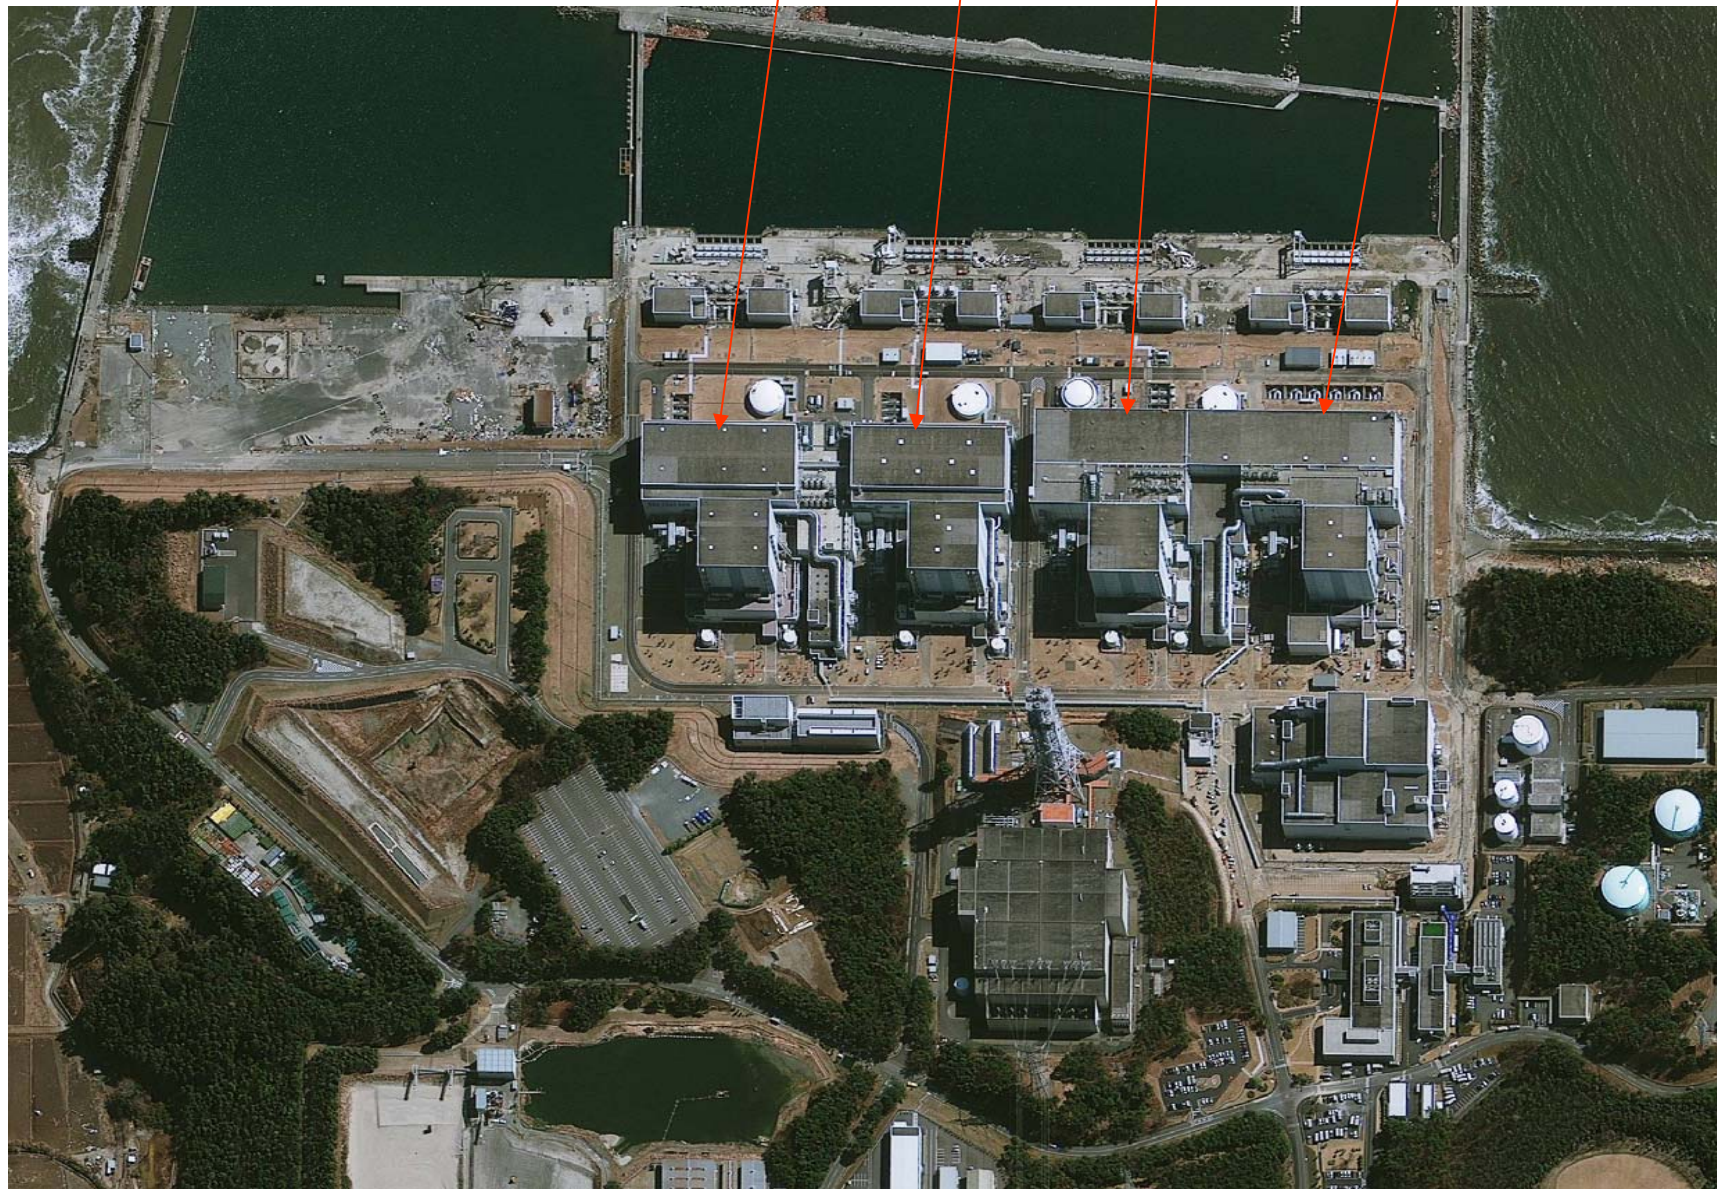
Aerial shot of Fukushima Dai-ni before the tsunami: All 4 nuclear reactors were in operation.

Unit 4 (In operation) Unit 3 (In operation) Unit 2 (In operation) Unit 1 (In Operation)

Ground height: – The 4 reactors of Dai-ni were at 12m above sea level. The sea side where the seawater cooling systems are located is at 4m (above sea level). The immersion height was 7m (above sea level).

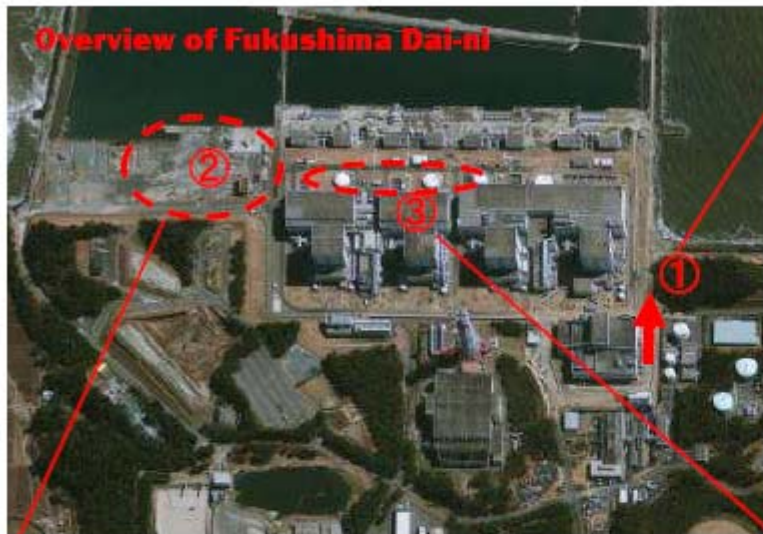
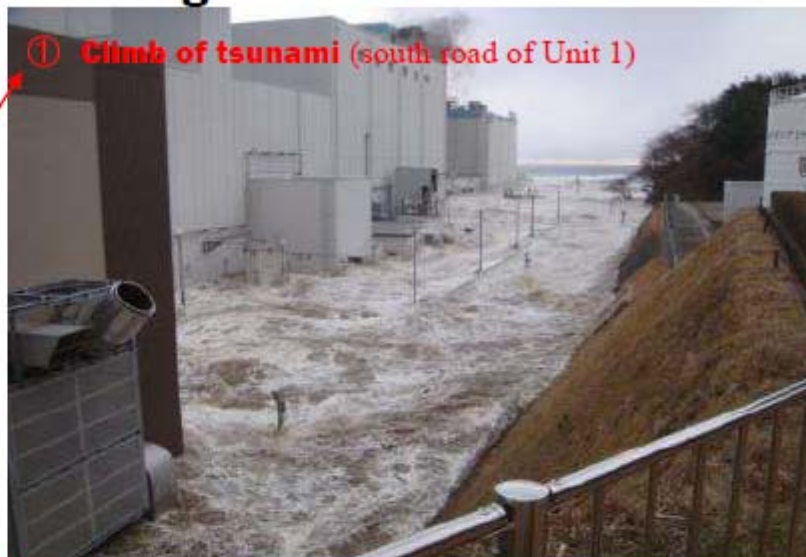
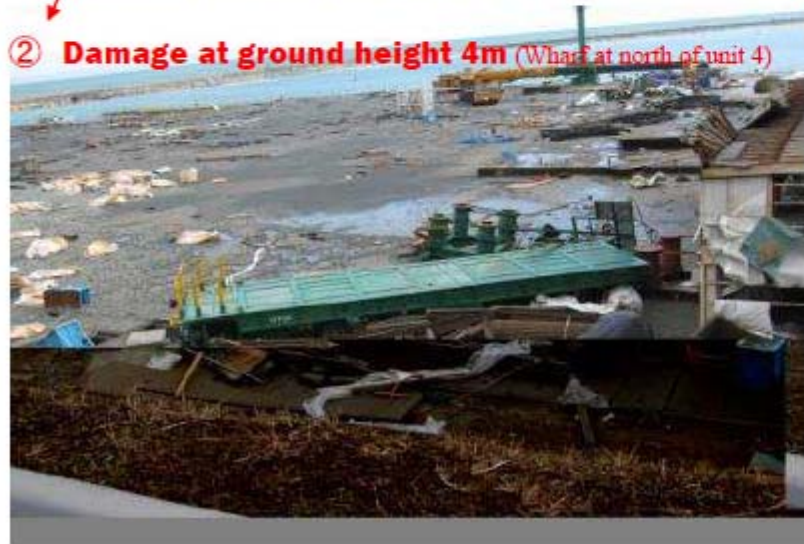
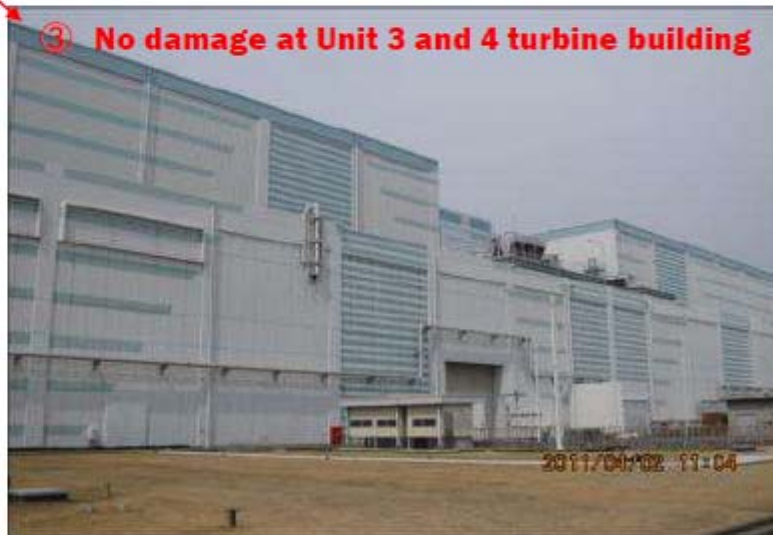
Damage of tsunami: It is concentrated at the south side of unit 1, along with the concentrated run, and the sea side where the ground level was low.

Tsunami, that directly hit Unit 1's south road, ran up to a maximum height of 14m. The water flowed around to the back of the nuclear reactor.

At the sea side, where the grounds were at 4m, heavy damage was caused by the tsunami, and debris is scattered everywhere

As the reactor & turbine buildings were at 12m, they were not damaged very much by the 7m tsunami.

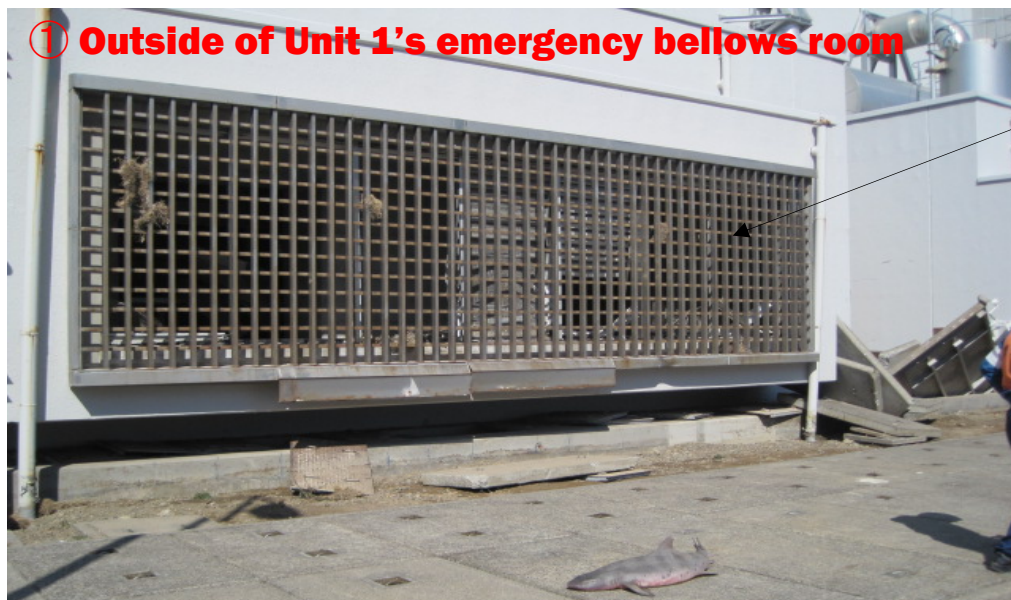
① Outside of Unit 1's emergency bellows room

Damage of tsunami (continued): Tsunami ran up along the south road and flooded into Unit 1 from the intake duct of its annex building.

Immersed from the intake louver of the reactor annex building.

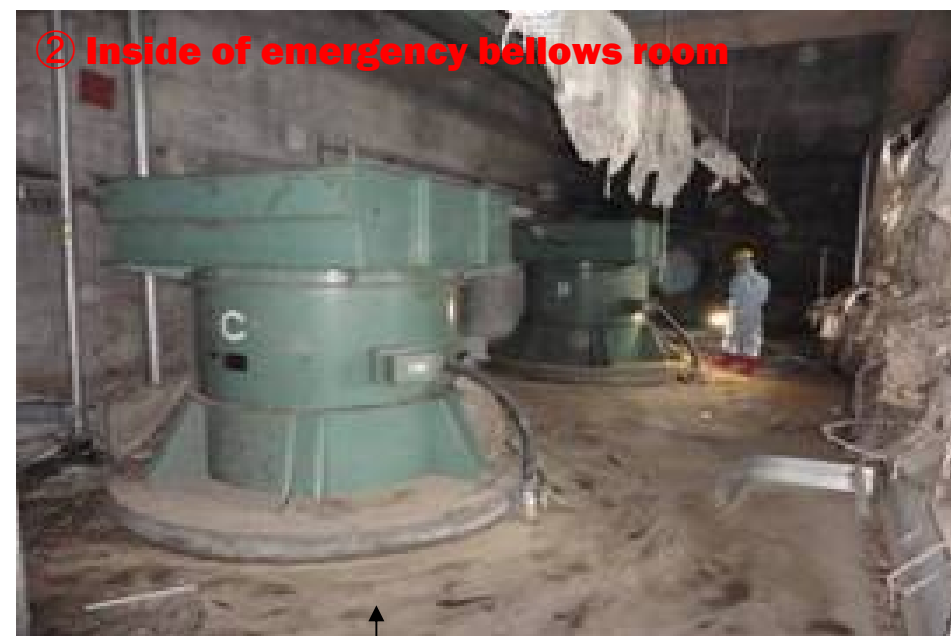
② Inside of emergency bellows room

Though immersed, there was no scatter of fixtures and facilities with no numerous debris as was in Dai-ichi.

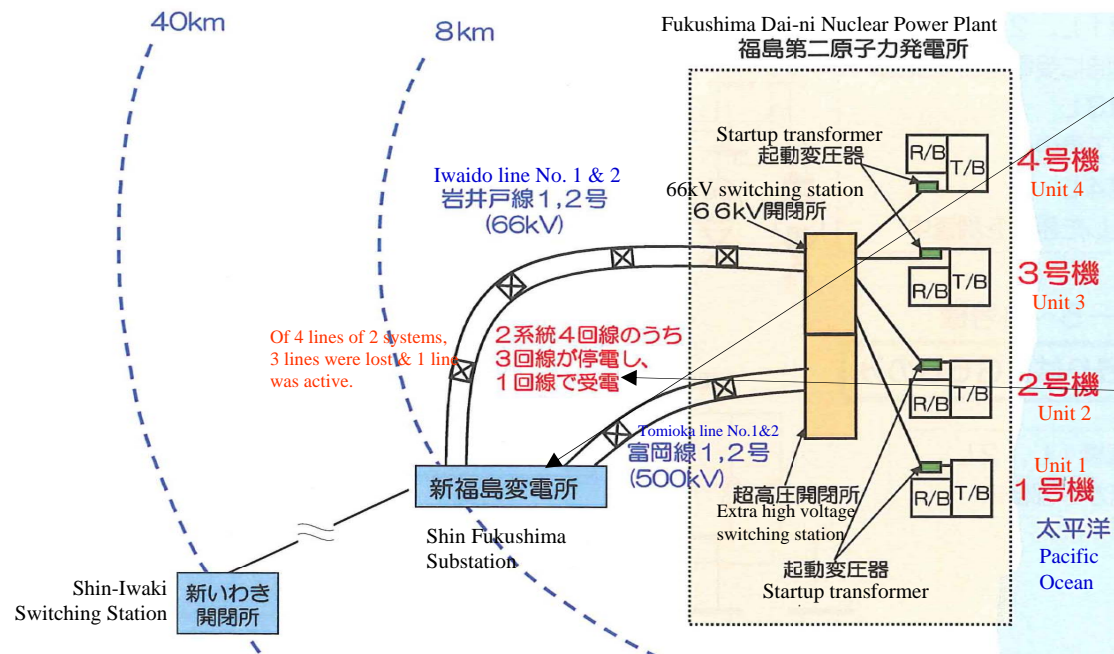
Damage to external power: At Fukushima Dai-ni, 3 out of 4 external power lines were lost due to the damage of transforming equipments at substations.

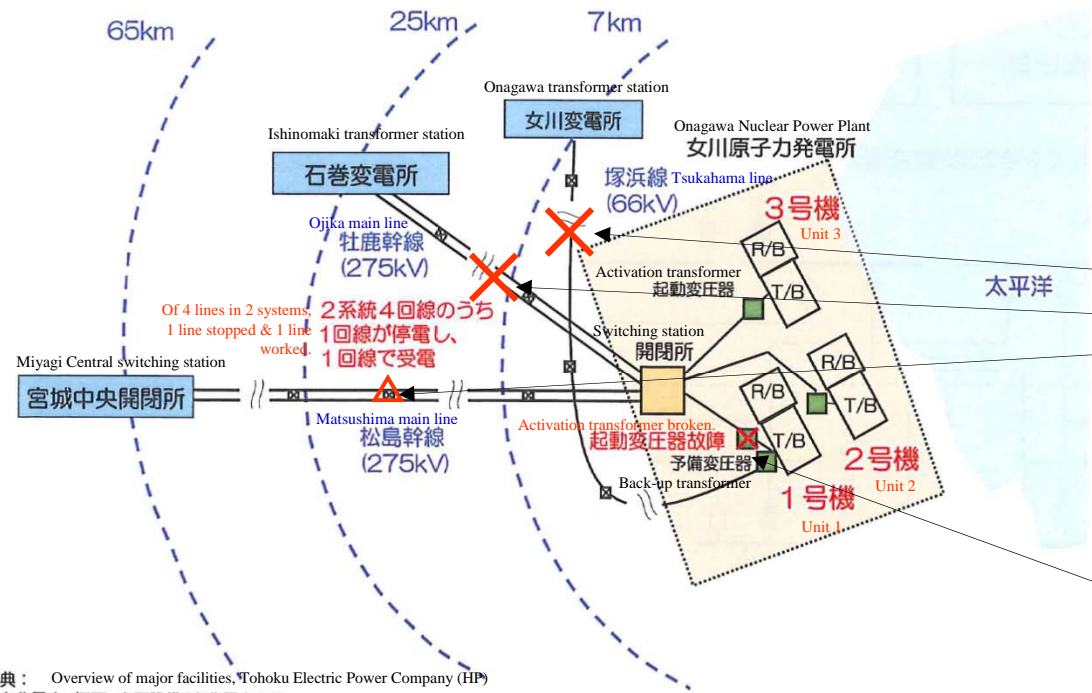
Damage to external power: 4 out of 5 external power lines were lost due to the damage to switching and transformer substations by the earthquake. On-site star-up transformer was also damaged.

Of 4 lines in 2 systems,
1 line stopped & 1 line worked.
2系統4回線のうち
1回線が停電し、
1回線で受電

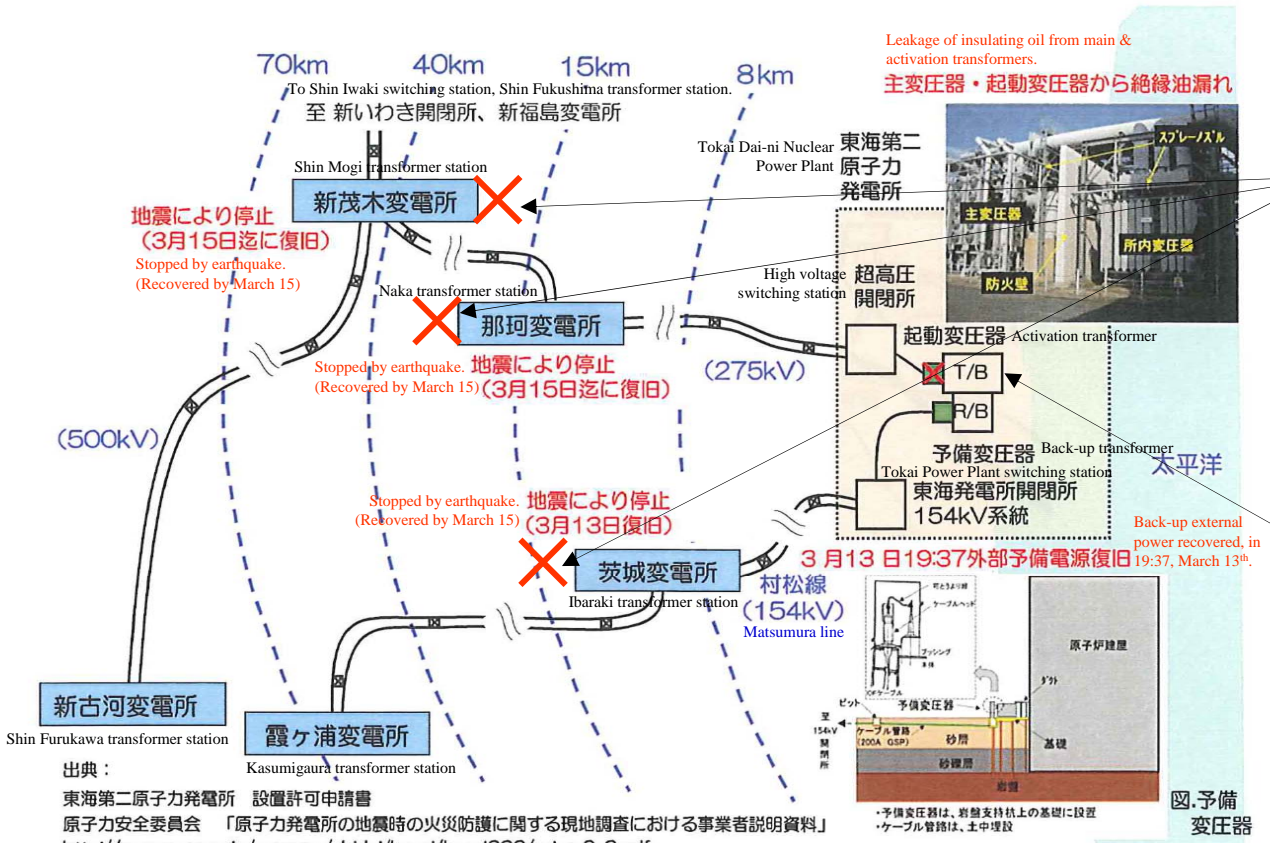
Damage to external power: As Naha and Ibaraki transformer stations stopped by strong seismic motion, all the external power was lost. Insulating oil was leaked from transformer in the plant.

Transmission from transformer station => All stopped due to earthquake.

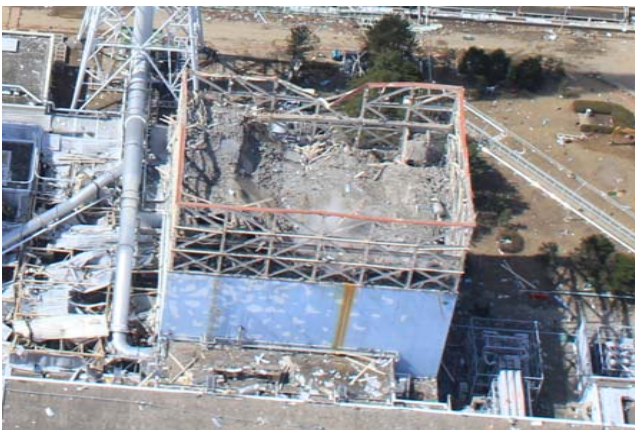
The reactor building had no system to “detect” or “release(*)” hydrogen, resulting in a massive explosion. ※)Emergency gas treatment system did not function because of the power outage

Reactor No.1 (East side)
Hydrogen built up in the 5th floor

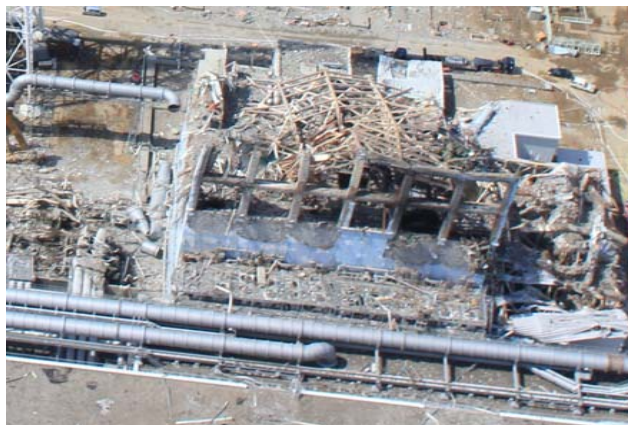
Reactor No. 3 (East side)
Hydrogen built up in the 5th & partially in the 4th floor (north-east)

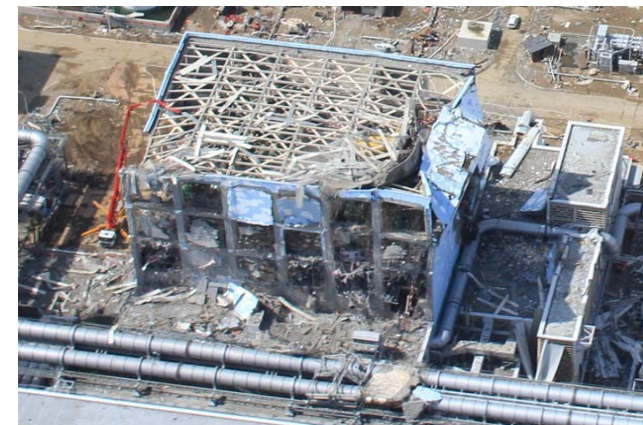
Reactor No. 4 (East side)
Hydrogen built up in the 5th & partially in the 4th, floor (east west)

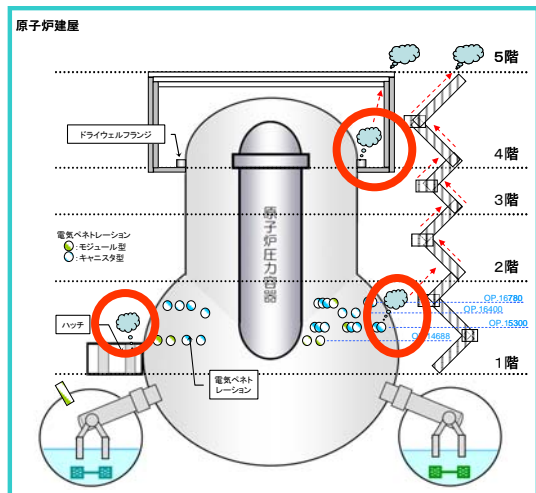
- Leak path-1 (Reactors 1&3): It is estimated the hydrogen leaked into the reactor building through gaps in the connections and piping (hatch, drywell flange, electric penetration).

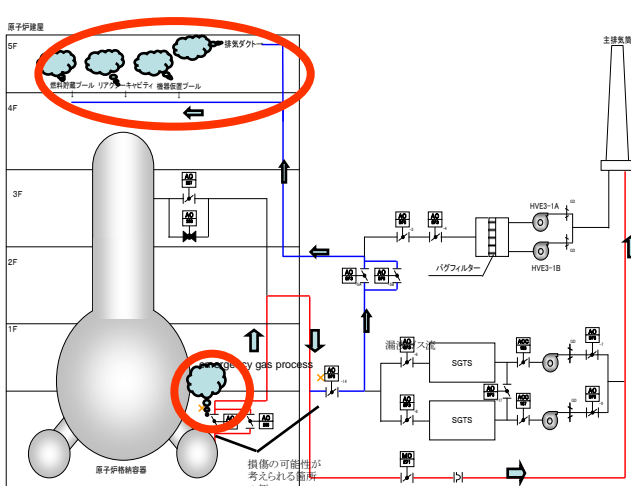
- Leak path-2 (Reactors 1&3): It is also possible that high-pressure & -temperature gas passed through vent lines and damaged the pipes and valves during the ventilation of the PCV, creating gaps for the hydrogen to leak through.

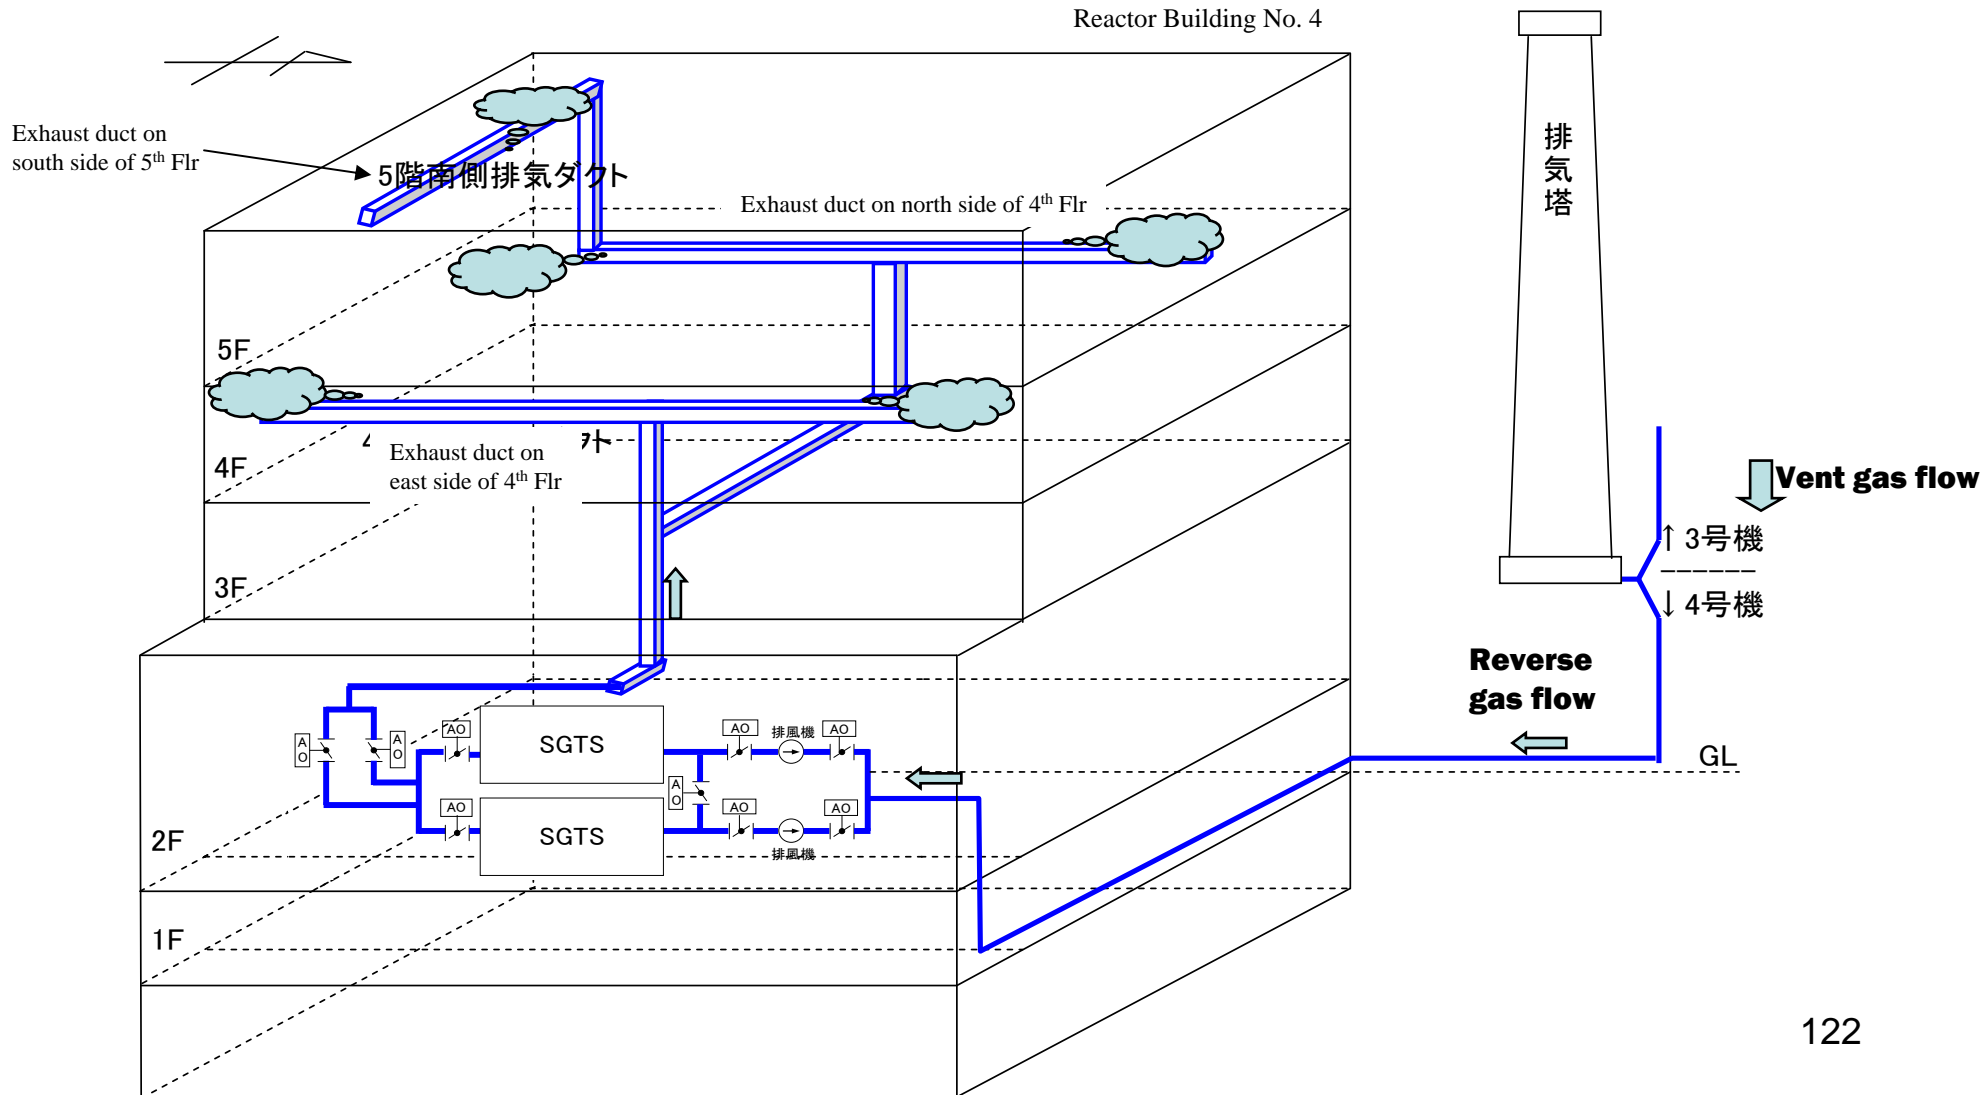
(Reference) Unit 3 & 4 SGTS exhaust duct

H₂ leak scenario at unit 4: Reverse flow from unit 3: The emergency SGTS* exhaust duct of Unit 4 is connected to Unit 3 right before the flue. Gases (including hydrogen) from Unit 3 may have flowed through into Unit 4. (*: Stand-by Gas Treatment System)

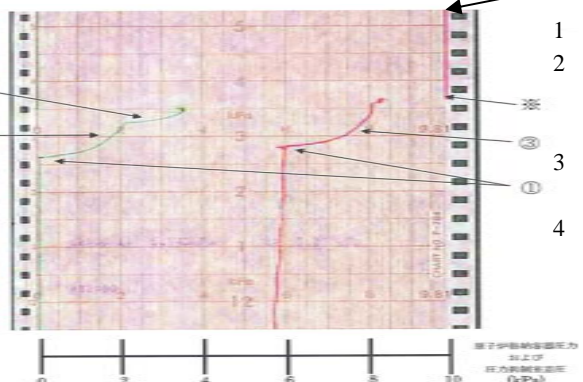
— Pressure in primary containment vessel (PCV)
 — Difference in pressure between SC and PCV

- 14:46 Scram started after earthquake.
- Increase in pressure difference between SC and PCV, caused by the rise in pressure in PCV.
- Increase in pressure in PCV, caused by the stop of air-conditioner in PCV.
- Decrease in pressure in SC, caused by cooling of SC. (The difference increased further.)

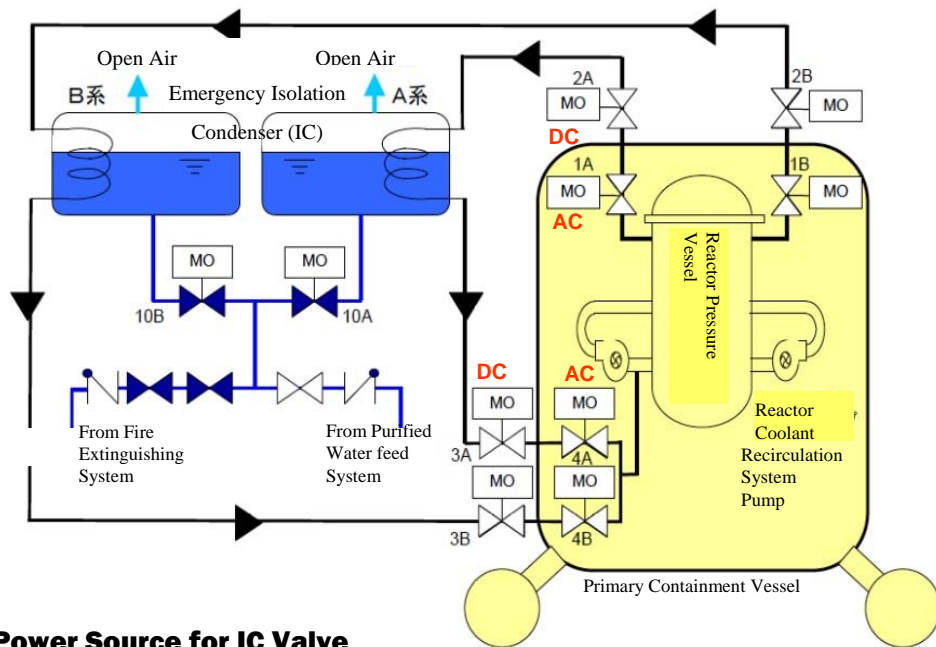
Power Source for IC Valve

Issue 3: How had the tsunami and complete loss of AC/DC power affected IC functions? => As its internal valves (AC driven) were designed to close in case of power loss (= fail-close), these valves were closed and its cooling function was lost.

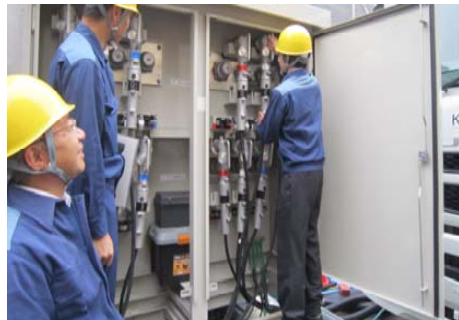
- Connection port and cables are installed right next to the DG to avoid unnecessary transportation
- Located in altitude of over 30m.

Measures for quick and secure connections

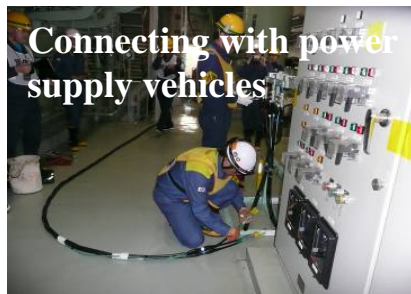
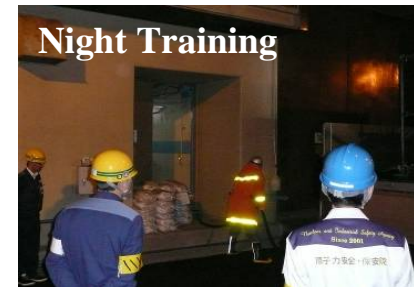
Connecting with power supply vehicles

Number of trainings conducted (as of Oct 28, 2011)

Weekdays	14
Night	3
Weekends	2

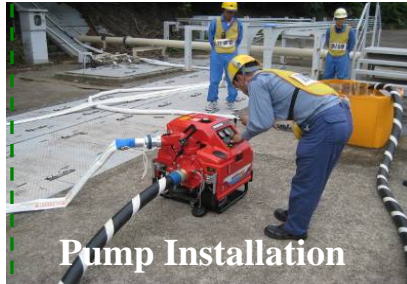
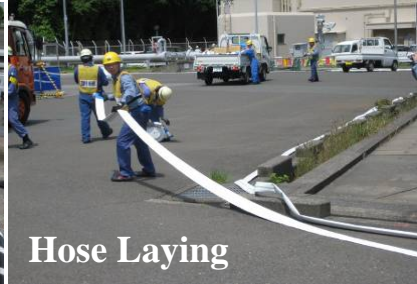
- Install pumps
- Lay down hoses
- Operate pumps
- Fuel pumps

- Put marks on the points to install pumps.
- Prepare transceivers for closer communication

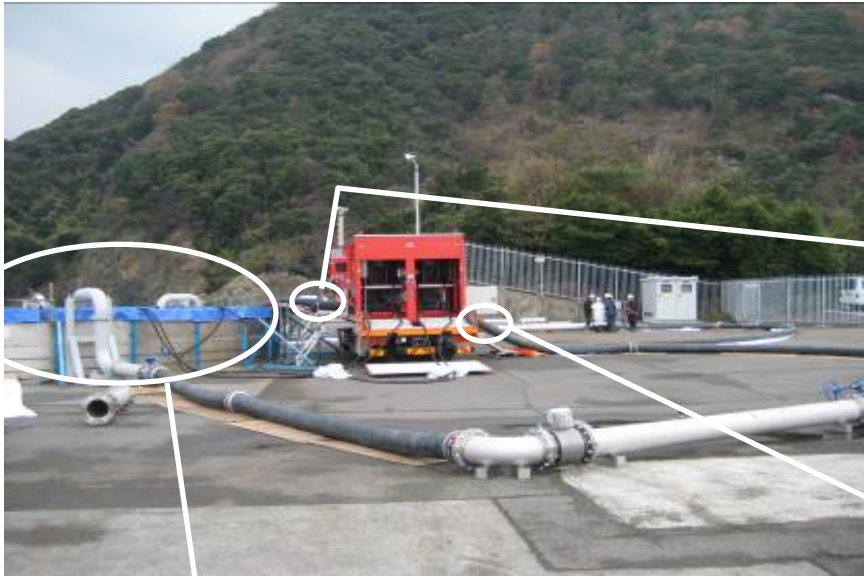
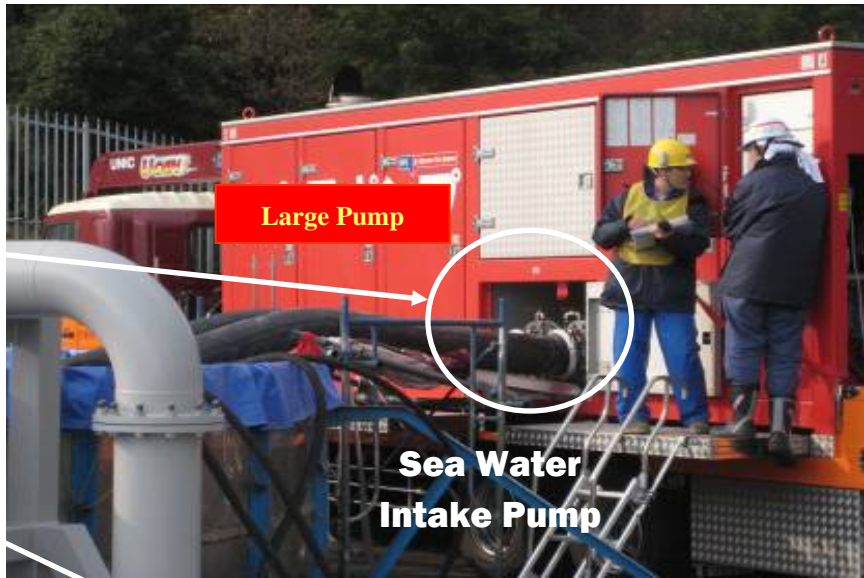
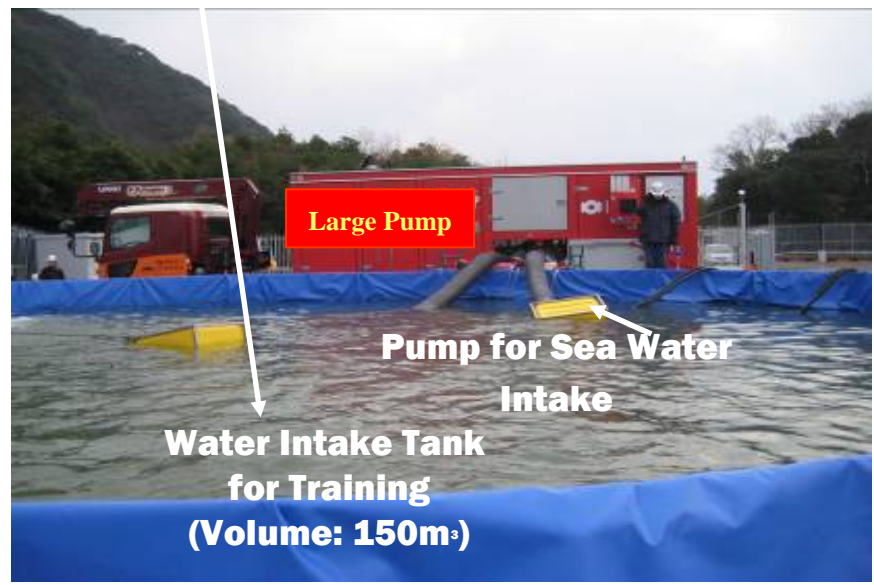
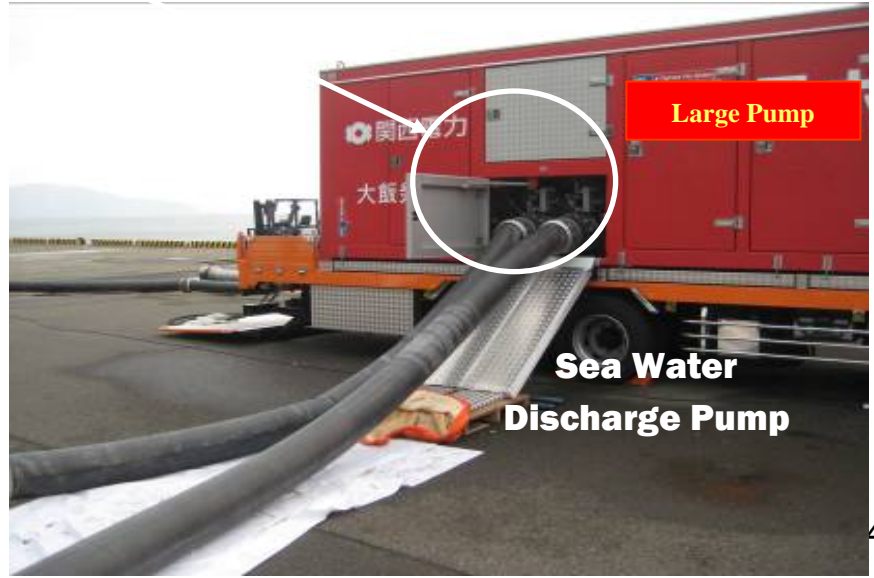
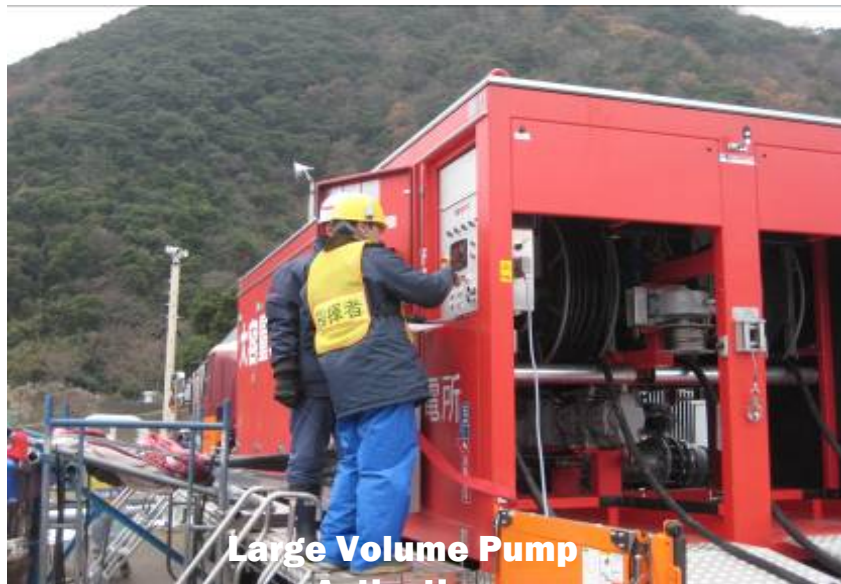
2. Securement of Cooling Water: Training for the large volume pump, installed in December, 2011, and currently in the process of implementation.

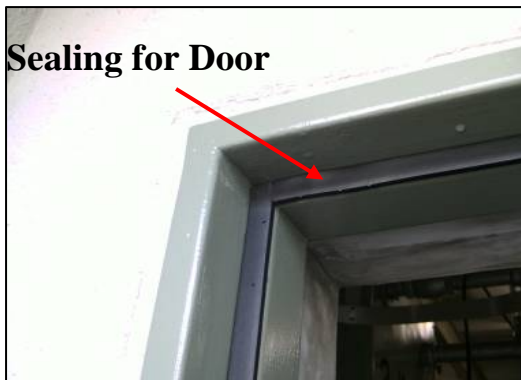
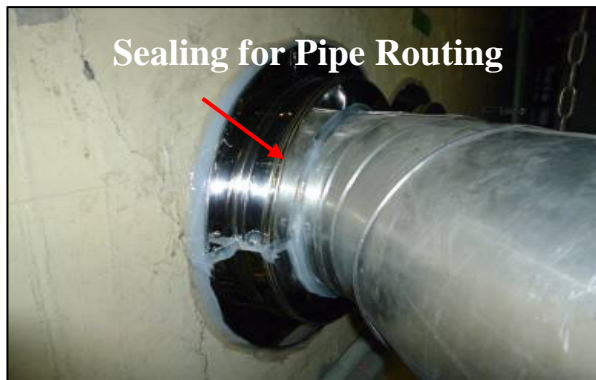
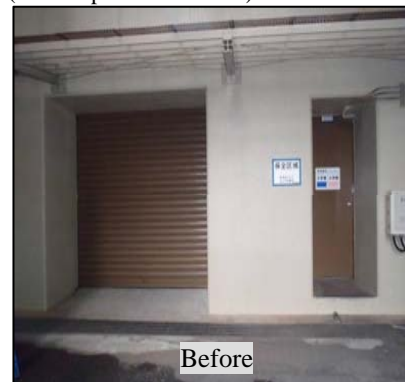
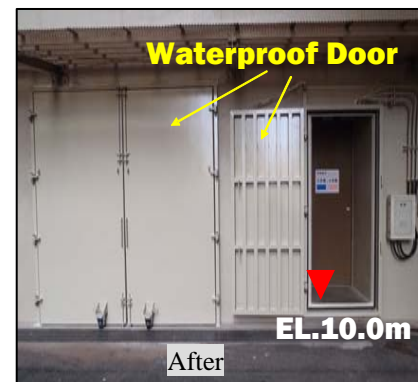
3. Countermeasure against Flooding: In order to protect emergency DG's and TD/MD-AFWP's* located at lower level, the waterproof sealing up to the altitude of 11.4m were implemented . (*: Turbine-Driven Auxiliary Feed-Water Pump, Motor-Driven Feed-Water Pump)

In case of complete submergence at outside of TD-AFWP room, water level rises 0.3cm/hr. (from experimental data)

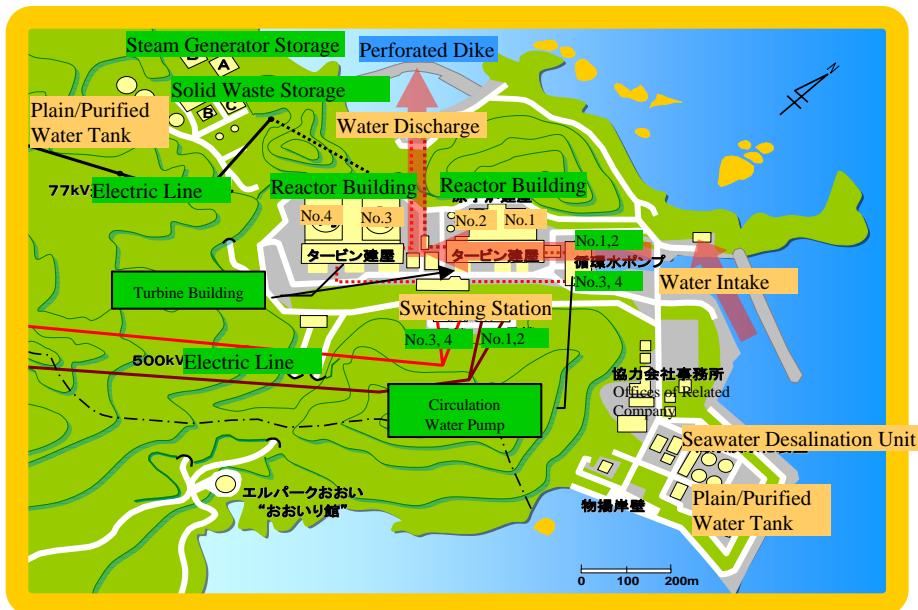
Ooi Nuclear Power Plant

Path of Sea Water: Since paths for water intake/discharge are located in the same place in all plants, diversification would be more effective such as portable pumps etc.

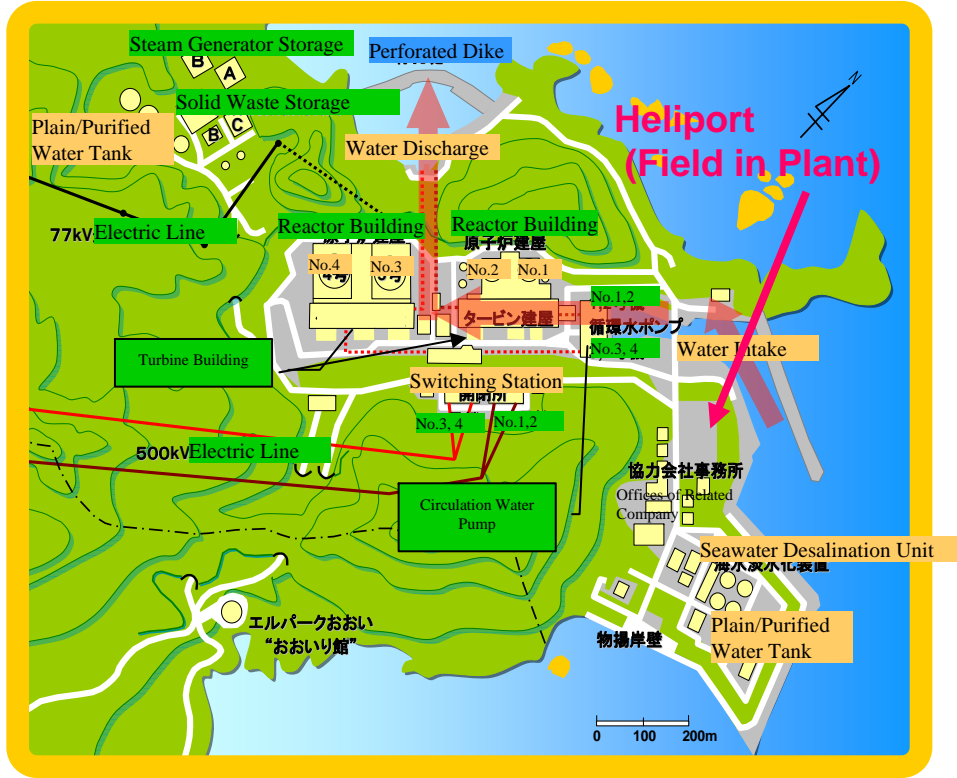
Logistics for Emergency such as Heliport & Fire Pumps: Though their locations, carry-in route, and procedures are defined in the manual, it is important to enhance their proficiencies through trainings.
